### INSPECTION – WING REAR SPAR AND FLAP/AILERON HINGE BRACKETS

<b>Service Bulletin No.: V2/0009</b>	<b>Date of Original Issue: 26 Jul 2016</b>
<b>Revision No: Revision A</b>	<b>Date of Issue: February 10, 2017</b>

NUMBER: V2/0009

**SUBJECT: INSPECTION – WING REAR SPAR AND FLAP/AILERON HINGE BRACKETS****I. PLANNING INFORMATION****A. Effectivity**

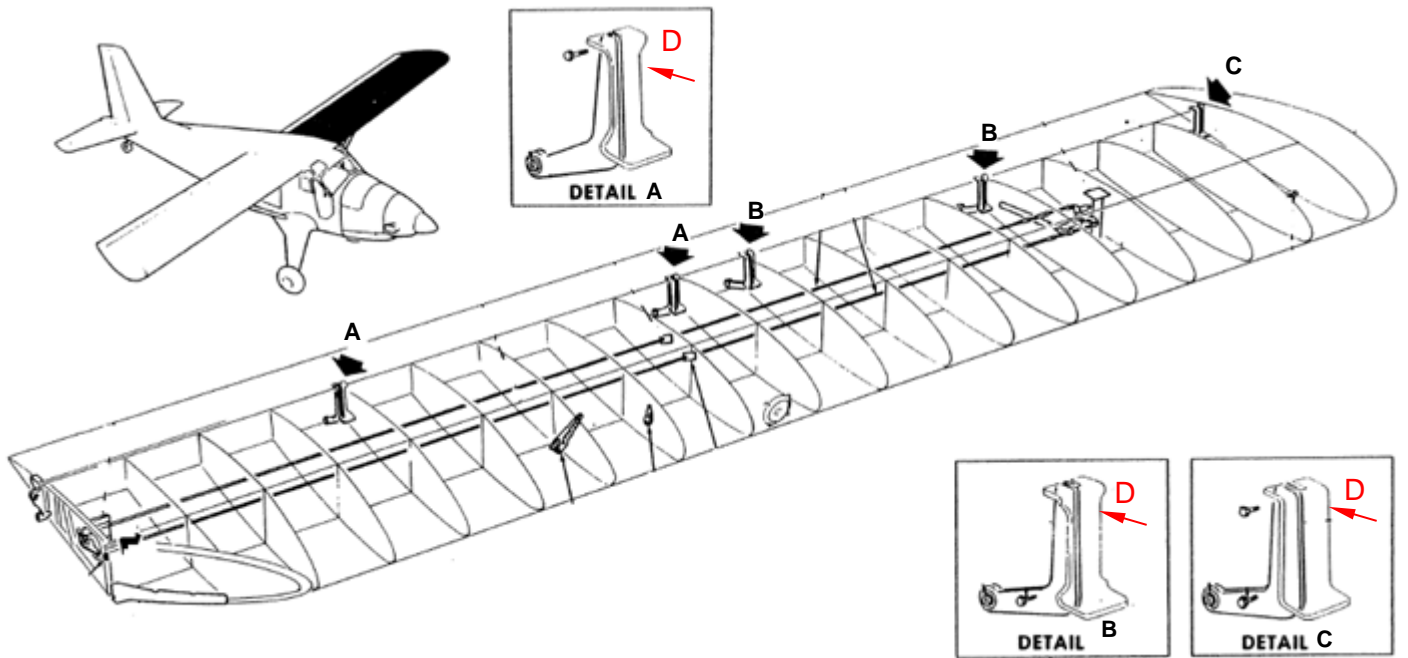
There has also been one report that the aileron middle hinge bracket cracked at the lower attachment hole at WS 191.0. Similar cracks may develop on the hinge flap/aileron bracket at the other attachment locations WS 1.25, 56.0, 123.5, 137.0 and 246.0 (including the exterior store support arm bracket at WS 101.24 if it is installed).

Crack location and orientation on hinge arm support bracket (typical)

6. With the aid of strong light and minimum 10X magnifier glass, visually inspect all aileron/flap hinge arm support brackets for cracking at lower attachment fastener hole (on both flanges) at WS 1.25, 56.0, 123.5, 137.0, 191.0 and 246.0:

8. Repair or replace discrepant parts as required before further flight.
9. Re-install removed parts in Section II.A.1 to II.A.3
