SUBJECT: Potential decreased service life of Slick 4-cylinder magneto distributor gear assemblies.

ISSUED			REVISED		
MO	DAY	YR	MO	DAY	YR
07	02	15

ATTN: Slick SB1-15 Returns

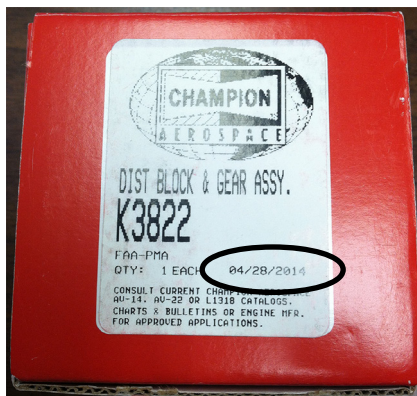
Figure 1. Replacement Kit Box Label

The following 4-cylinder magnetos with serial numbers between 13110001 thru 14070600, K3822 distributor block replacement kits, and K3008 distributor gear assemblies dated November 1, 2013 thru July 10, 2014:

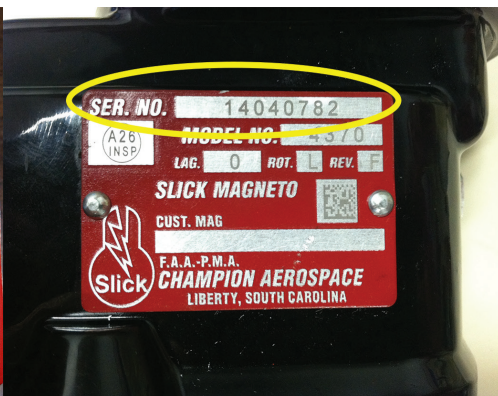
Figure 2. Magneto ID Label

NOTE: 1311XXXX = SN manufacture date of November 2013 and 1407XXXX = SN manufacture date of July 2014
