# AG-CAT SERVICE NOTES and BULLETINS

**GRUMMAN** AMERICAN AVIATION  
CORPORATION

AG-CAT SERVICE BULLETINS

## SERVICE BULLETIN INDEX

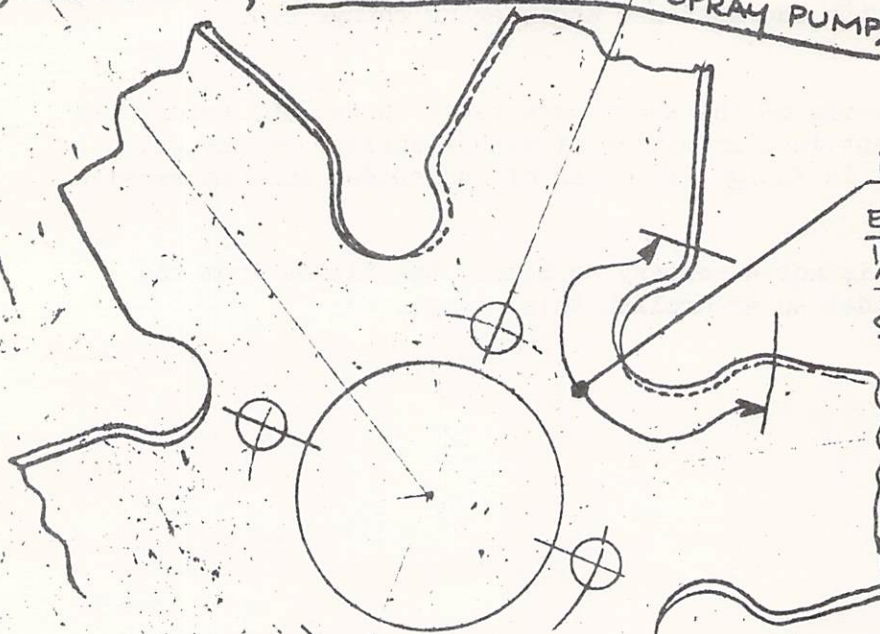
- ① SHARP EDGES INVITE PROBABILITY of SPIDER CRACKING  
 & BLADE THROWING DUE TO SHARP CORNERS CONCENTRATING  
 STRESSES AT SECTION of MAXIMUM BENDING LOAD PER  
 FAN BLADE.
- ② FAN NOW INSTALLED INTERCHANGEABLE  
 ON 2" SIMPLEX OR ROOT MODEL 57 PUMPS.

- ① REWORK SPIDER of PUMP FANS IN AREA NOTED BELOW  
 ② CHG TITLE TO: "FAN ASSY & SPACER - SPRAY PUMP" PER INSTRUCTIONS:-

ROUND OFF BOTH  
 EDGES of SPIDER  
 $\frac{1}{32}$  TO  $\frac{1}{16}$  RADIUS  
 & DRESS RADIUS

WITH FINE EMERY  
 CLOTH SO THAT  
 NO MACHINE OR  
 FILE MARKS  
 SHOW. RE -  
 PRIME & PAINT

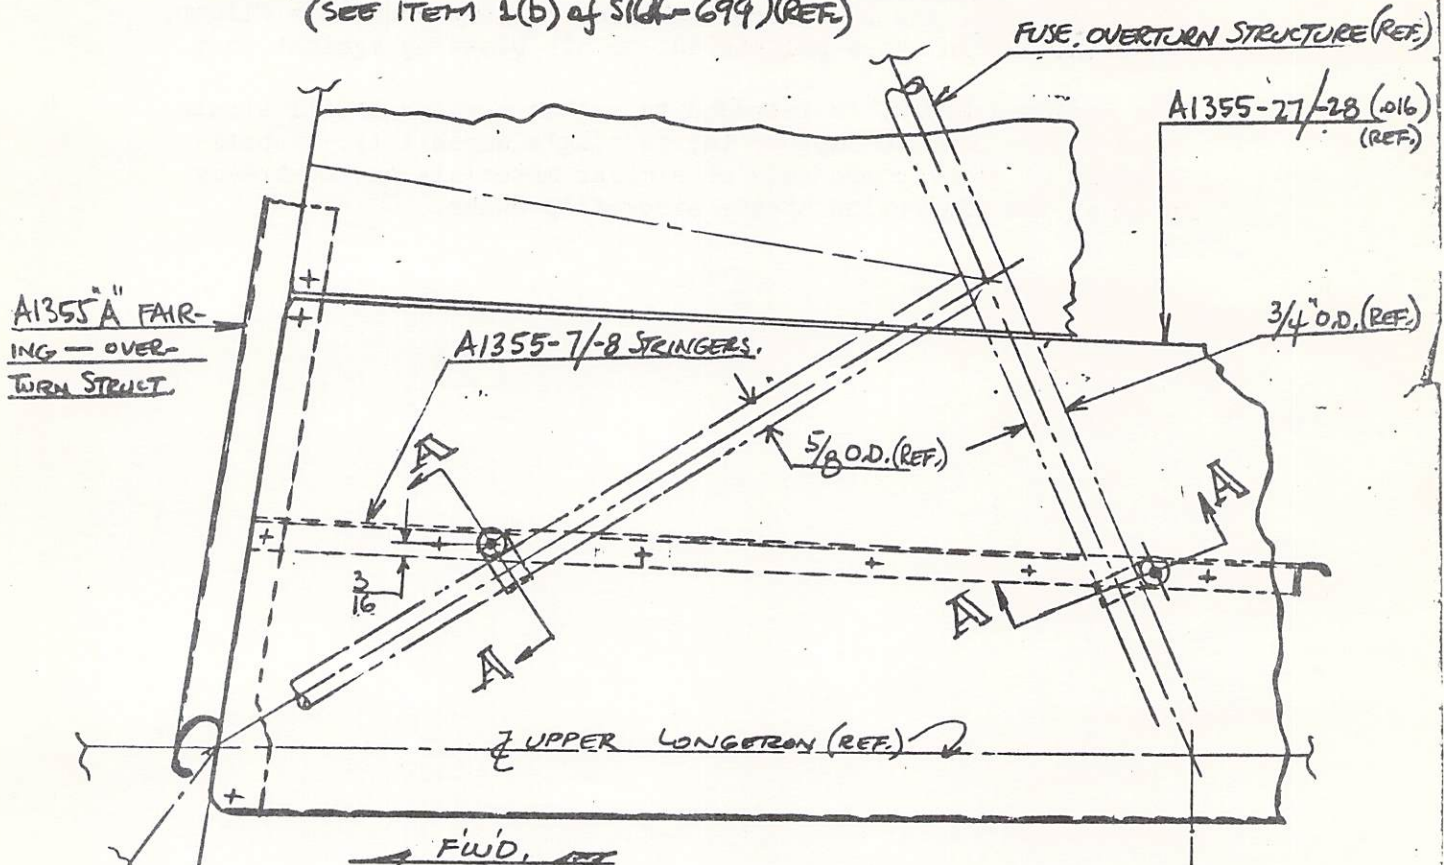
- ① TO STIFFEN SIDE SKINS AGAINST DRUMMING & CRACKING.

CHANGE: ① ADD CLAMPS & SPACERS AS SHOWN ABOVE TO INSTALL. of A1355"A" OVERTURN STRUCTURE FAIRING.  
(SEE ITEM 1(b) of S164-699)(REF.)

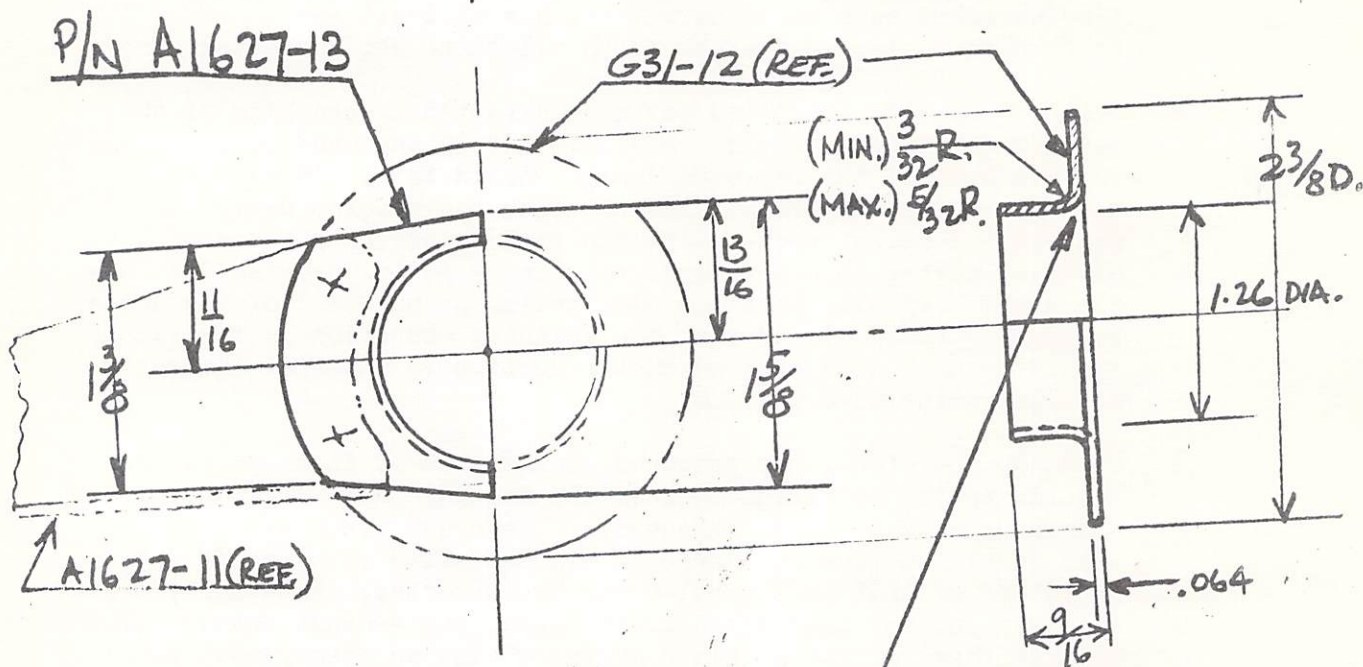
2. Again, Grumman's attention has been directed to cracking of the replacement type brackets. A careful study was made to determine why brackets of the improved design should fail. It has been determined that the fault lies not with the bracket design or material used, but rather with the failure of the sub-contractor of these parts, in his failure to closely follow drawing instructions which specify that the bend radius at the heel of the angle be  $3/32$  R. (inside) and that the spinning operation on the flange should be done with care so that reduction in material thickness at this radius is a minimum.

ORIG. SHAPE OF P/N A1627-13 CAUSED FATIGUE FAILURES.

Change detail shape of P/N A1627-13 TO DETAIL SHOWN BELOW. USE EITHER  $.063$  2024-O SH'T (H.T. TO T4 AFTER SPINNING) OR  $.064$  5250 SH'T. (5250 SH'T PREFERRED)

SPIN CAREFULLY SO THAT MATERIAL REDUCTION AT THIS RADIUS IS A MIN.

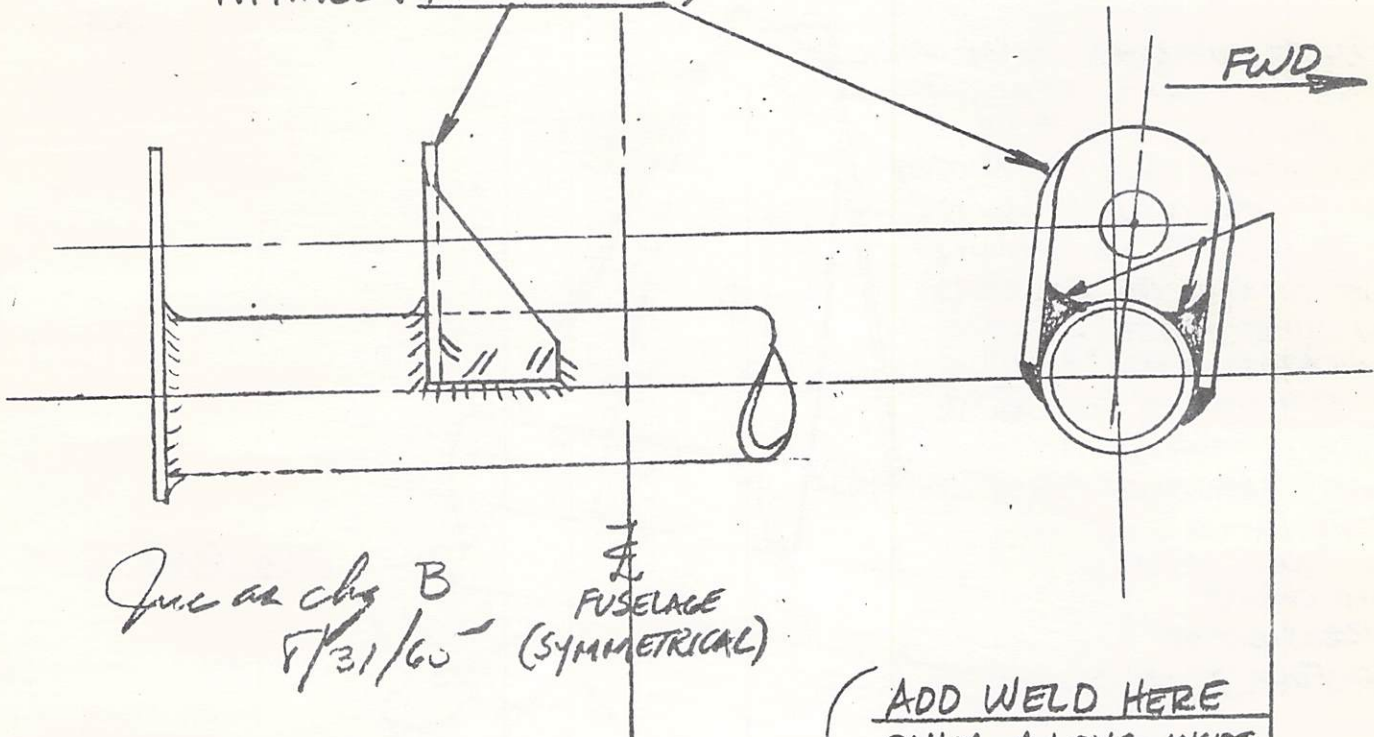
THIS FILL-IN IS DONE TO PREVENT POSSIBLE ACCUMULATION OF MOISTURE AROUND THE FITTINGS.

CHANGE: ① ADD WELD TO INSIDE OF STABILIZER REAR SPAR FUSELAGE FITTINGS <sup>(2)</sup>(P/N A1306-11) AS SHOWN BELOW.

② THIS ADDED WELD SHALL START WITH A/C #66 IN PRODUCTION. ALL OTHER PREVIOUS A/C (AT FACTORY OR IN SERVICE) SHALL NOT BE WELDED IN THESE AREAS FOR FEAR OF CRACK DEVELOPMENT. THEY SHALL BE FILLED IN WITH A GENEROUS FILLET OF "3M" SCOTCH CAULK (OR EQUIV.) WATER RESISTANT CAULKING COMPOUND.

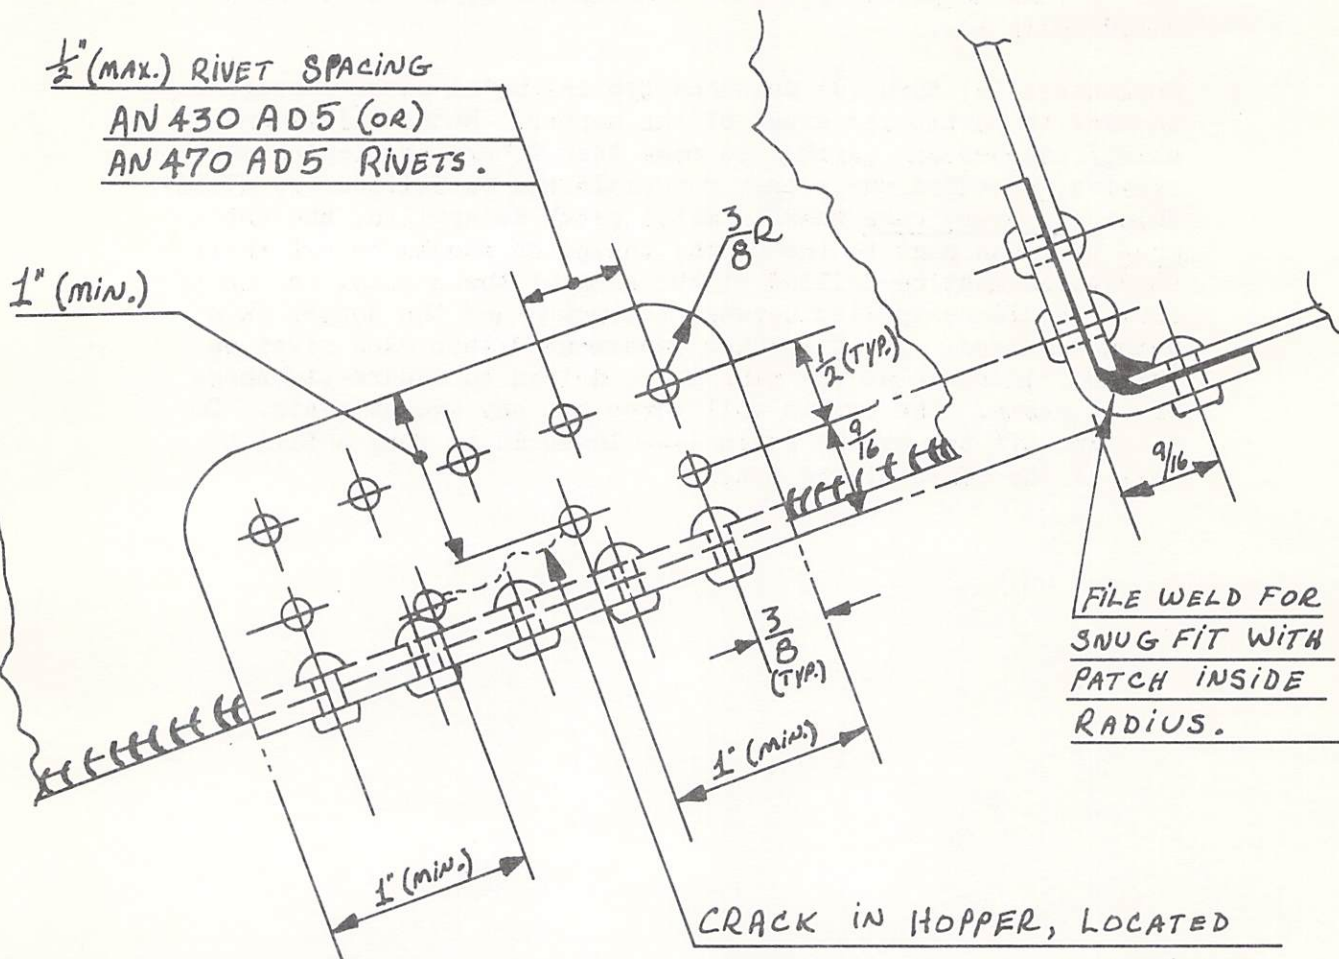
TYPICAL EDGE PATCH (STRAIGHT SECTION).

CRACK IN HOPPER, LOCATED  
EITHER NEAR THE WELD JOINT  
OR ALONG THE WELD (NOT SHOWN)  
(NOTE THAT STOP-HOLES HAVE BEEN  
DRILLED IN ENDS OF CRACK).

THE PATCH SHOWN ABOVE IS THE  
MIN. SIZE TO FIT THE CRACK  
SHOWN. MATERIAL IS 52S'4H,  
6150, 1780 OR 2450 ALUM. ALLOY SH'T,  
 $\frac{1}{8}$ " THICK & BENT TO  $\frac{1}{8}$ " BEND RADIUS.

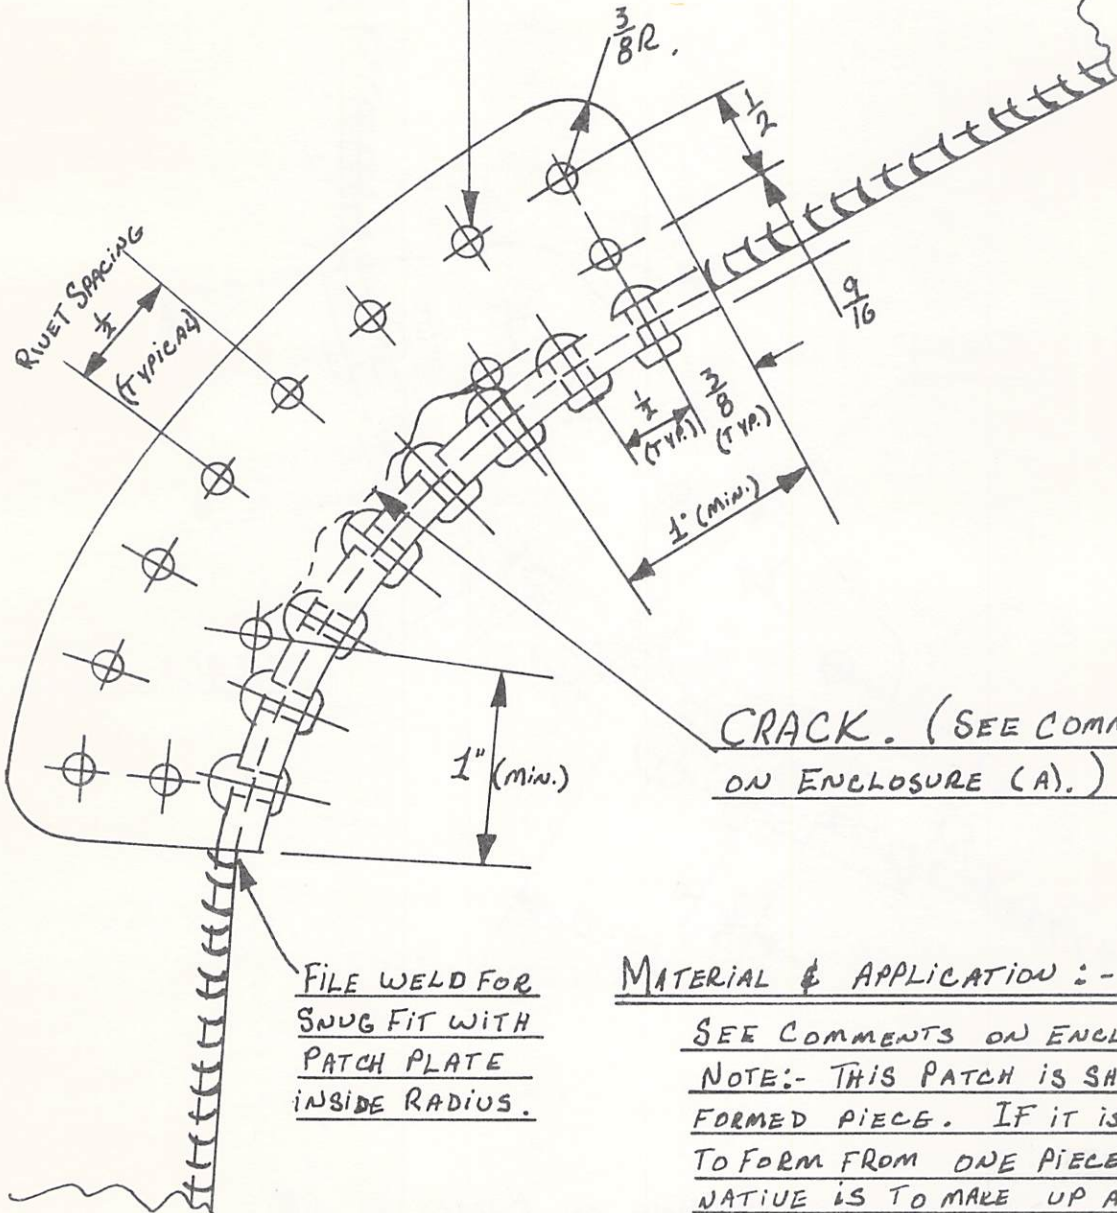
CRACK. (SEE COMMENT  
ON ENCLOSURE (A).)

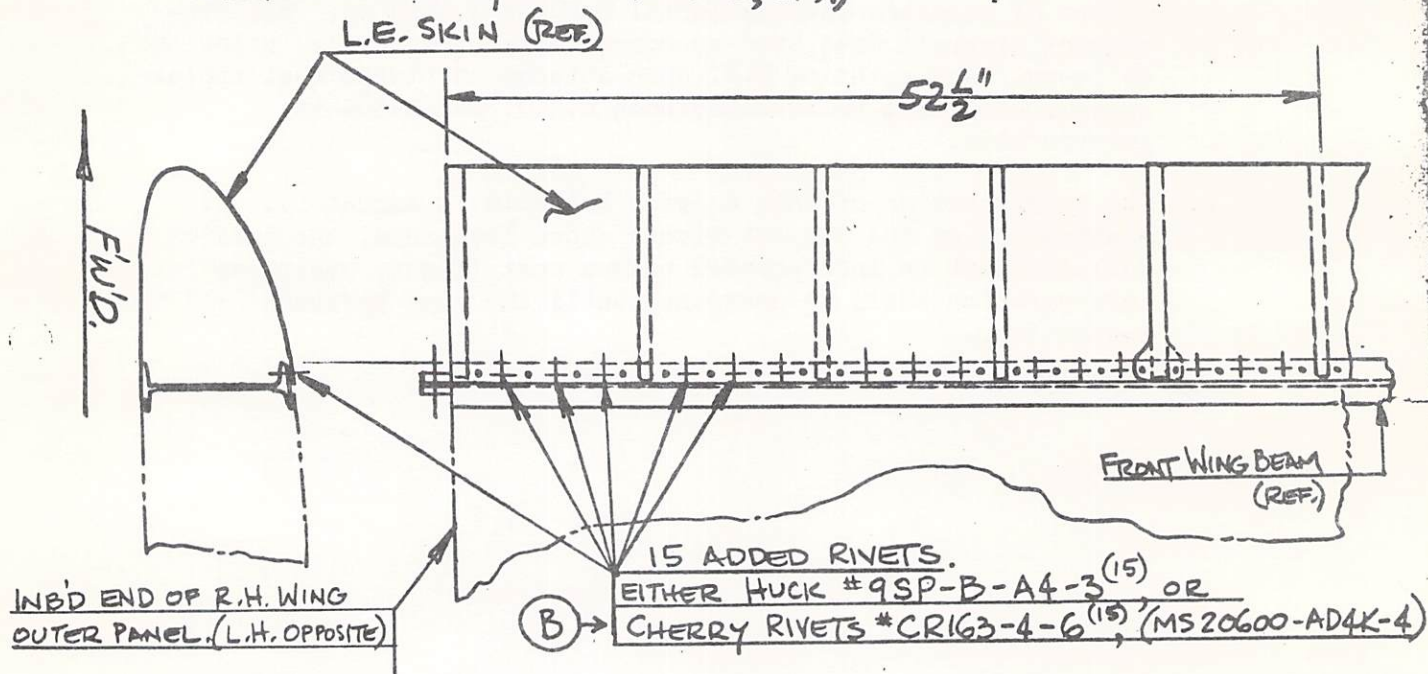
1. Rivets attaching the wing L.E. skins to the upper capstrips of the forward wing beams were reported as loosening on several G-164 aircraft of early manufacture. This loosening has been attributed to propeller blast action. The attached E.C.O. #S164-684 indicates the corrective action to be taken by all owners of aircraft bearing serial numbers 1 thru 85. All subsequent aircraft have been so corrected at the factory prior to delivery. Any existing L.E. skin attachment rivets that appear to be loose shall be replaced when E.C.O. #S164-684 is incorporated.
2. The incorporation of this Service Bulletin is mandatory. If examination of the subject rivets shows looseness, the Service Bulletin must be incorporated before next flight; otherwise incorporation shall be postponed until the next periodic inspection.

REASON: 1. THESE ADDED RIVETS ARE REQ'D IN THE REGION OF THE PROP. SLIP-STREAM TO STRENGTHEN THE L.E. SKIN ATTACHMENT AGAINST PROP BLAST ACTION. THIS IS A MANDATORY CHANGE!

CHANGE: 1. ADD 15 HUCK RIVETS (#9SP-B-A4-3) OR 15 <sup>(B)</sup> CHERRY RIVETS (#CR163-4-6 OR #MS 20600-AD4K-4) AS SHOWN BELOW TO EACH OF FOUR (4) WING OUTER PANELS FOR ATTACHING L.E. SKINS TO THE FORWARD WING BEAM UPPER CAPSTRIPS. THESE ADDED BLIND RIVETS ARE TO BE LOCATED MIDWAY BETWEEN EXISTING RIVETS (AS SHOWN ON SKETCH BELOW BY THE SYMBOL, (+).)

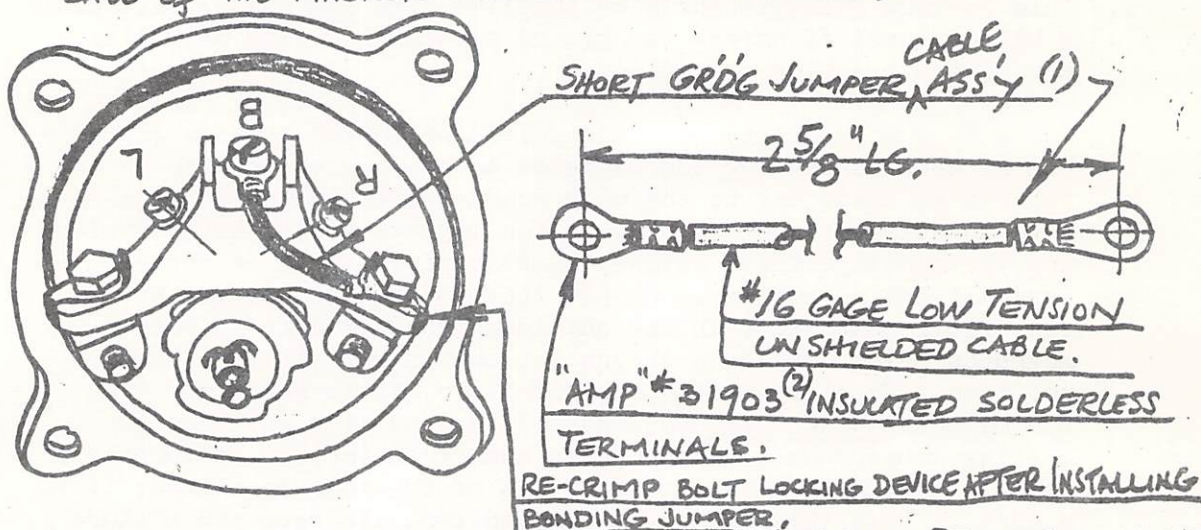
2. There is a possibility that the shielding on the primary electrical harness connecting the magnetos to the magneto switch on the subject aircraft may be the only conductor to the ground due to deterioration of contact between the magneto switch attach bolts and the fuselage frame (caused by corrosive action of certain agricultural chemicals). Should this condition exist, a break in electrical continuity in the shielding would result in both magnetos being "ON" even though the switch were in the "OFF" position. To eliminate this possibility, it is mandatory that the magneto switch case be bonded to ground with an external bonding jumper cable assembly per enclosure (a), 4. To further utilize the inherent safety features of the magneto switch, it is mandatory that this switch be removed from its case and a short internal bonding jumper be installed between the center contact marked "B" and the switch hex head bolt (brass) as depicted on enclosure (a), 2. Be certain that this bolt locking device is re-crimped against the bolt head after installation of the internal bonding jumper lug.

1. THIS CHANGE IS MANDATORY!
2. INSTALL SHORT BONDING JUMPER (DETAILED BELOW) INSIDE THE CASE OF THE MAGNETO SWITCH AS SHOWN BELOW:-

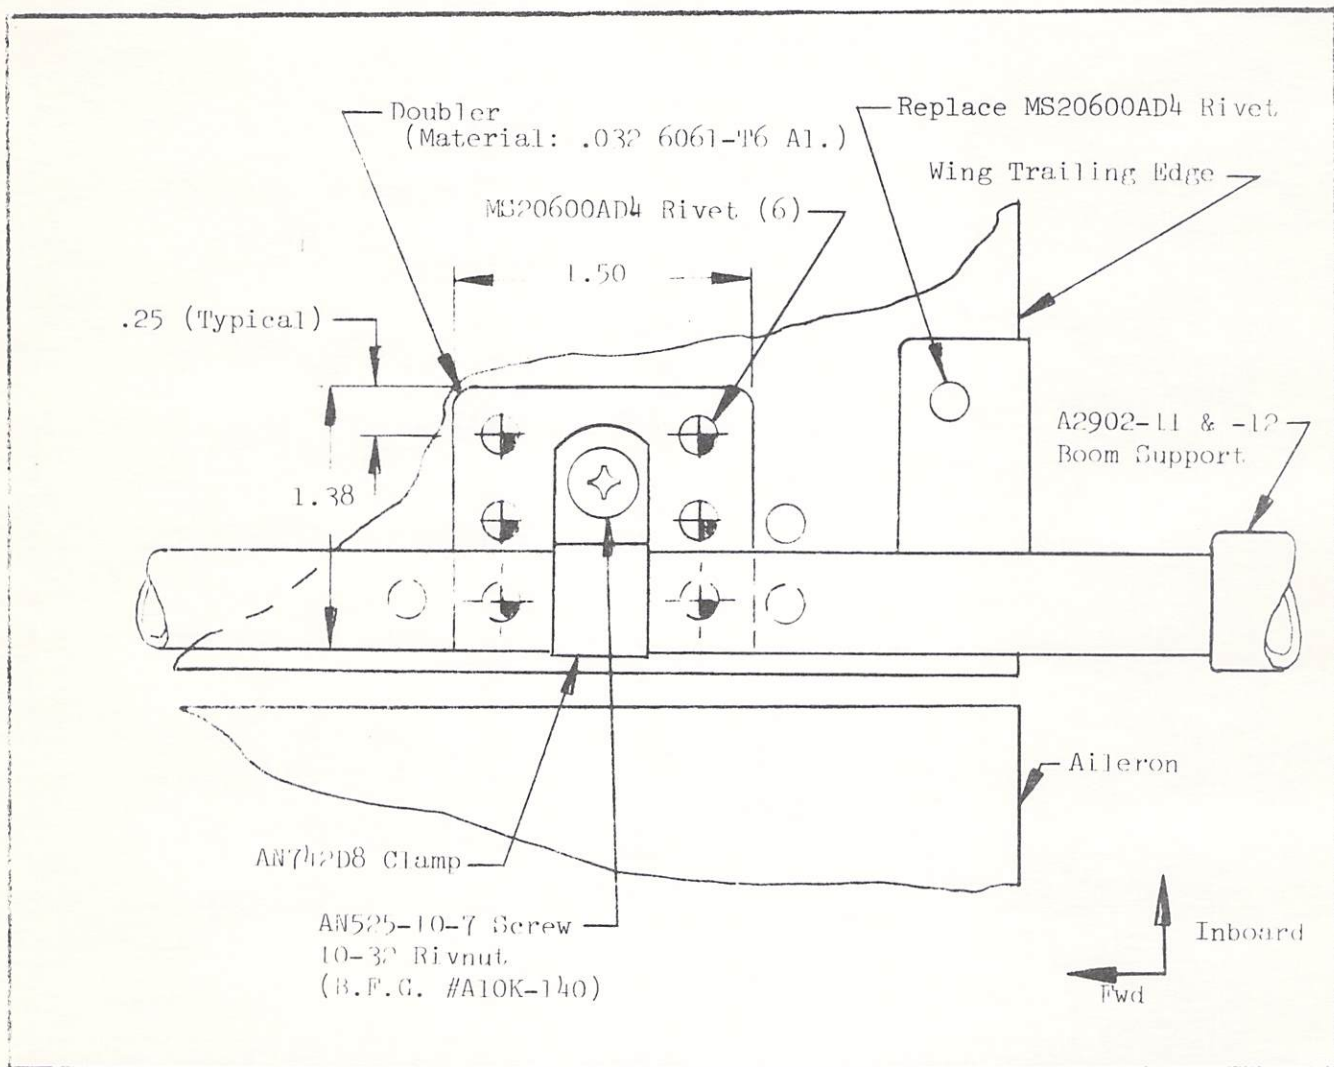
It has been suggested that the attachment for the trailing edge boom support is not adequate if in the event an extreme shear load is applied. To increase the shear strength capabilities of the attachment it is suggested that all applicable aircraft be modified in accordance with the drawing noted below.
