SAIB: 2022-20
Date: October 19, 2022

SUBJ: Wing Spar

This Special Airworthiness Information Bulletin (SAIB) alerts all owners, operators, maintenance technicians, and inspectors of **Piper Aircraft, Inc. (Piper) PA-28 and PA-32** airplanes of information gathered as result of a fatal accident of a Piper Model PA-28R-201 airplane in 2018 and the inspection findings that followed. The accident, determined to be caused by fatigue cracks in the lower spar cap, resulted in the Federal Aviation Administration (FAA) issuing Airworthiness Directive (AD) 2020-26-16, which requires several actions including a one-time inspection of certain lower spar cap bolt holes. AD 2020-26-16 was issued as an interim action and requires reporting certain inspection information to the FAA to help determine the number of cracks present in the fleet. The inspection reports received by the FAA thus far indicate the presence of numerous cracks and hole-quality issues in a significant number of airplanes.

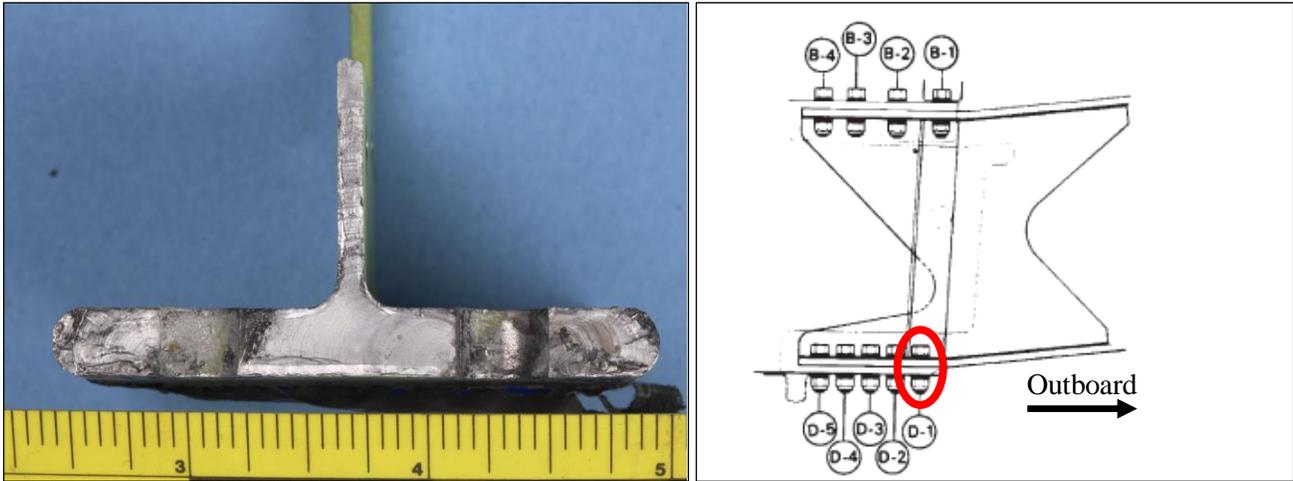
As stated above, the FAA issued AD 2020-26-16 due to a 2018 in-flight wing separation on a Piper Model PA-28R-201 airplane caused by fatigue cracks located in a visually inaccessible area of the lower main wing spar cap. Inspection of another airplane in the same fleet of the accident airplane (manufactured at a similar time and operated in a similar training mission) was also found to have cracking in the wing spar. The National Transportation Safety Board (NTSB) found fatigue cracking across an extensive cross-section of the lower spar cap. The crack and failure occurred across the T-section at the two most outboard bolt holes attaching the lower spar to the wing box (see Figure 1).

Figure 1. Spar Cap Failure at Outboard Bolt Holes (left), Spar and Center Wing Attachment Configuration, Failure Location Shown (right)

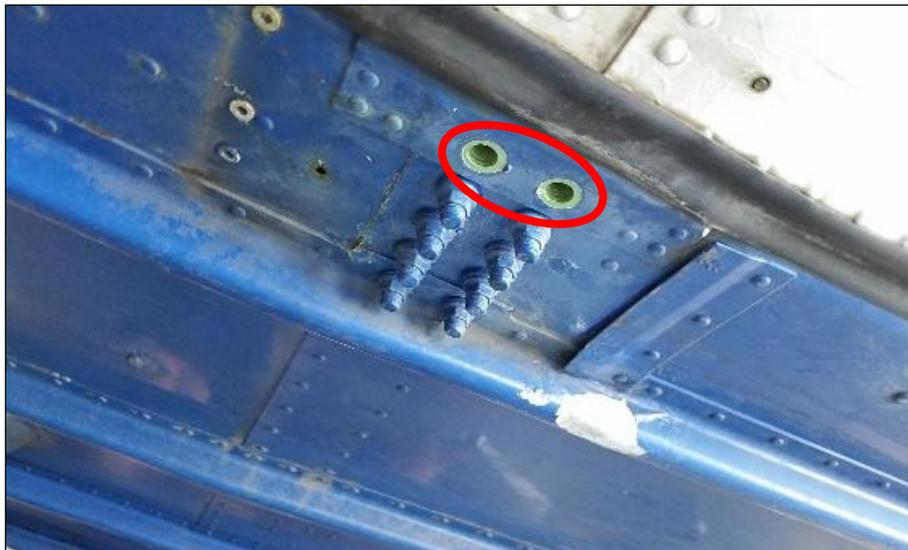
AD 2020-26-16 requires a one-time eddy current inspection of certain bolt holes of spars that have reached 5,000 factored service hours (FSH), and a reporting of the inspection results to the FAA and Piper. The inspections were required for the most outboard set of bolt holes, both forward and aft (see Figure 2). The eddy current inspection method is a non-destructive technique that utilizes electromagnetism to detect flaws on and under the surface of a part in question. The inspection method has certain limitations including the depth in the material where a flaw can be detected, the size of the flaw, and that a highly skilled and properly trained inspector is required, but it is a proven tool that is commonly used for inspections of this nature. The eddy current inspection method is capable of detecting cracks, but is also sensitive to surface anomalies that may cause cracks to form in the future, such as corrosion or gouges. Visual inspections are not sufficient to detect such cracks.

Figure 2. Outboard Bolts Removed and Location of Inspection, RH Wing Root

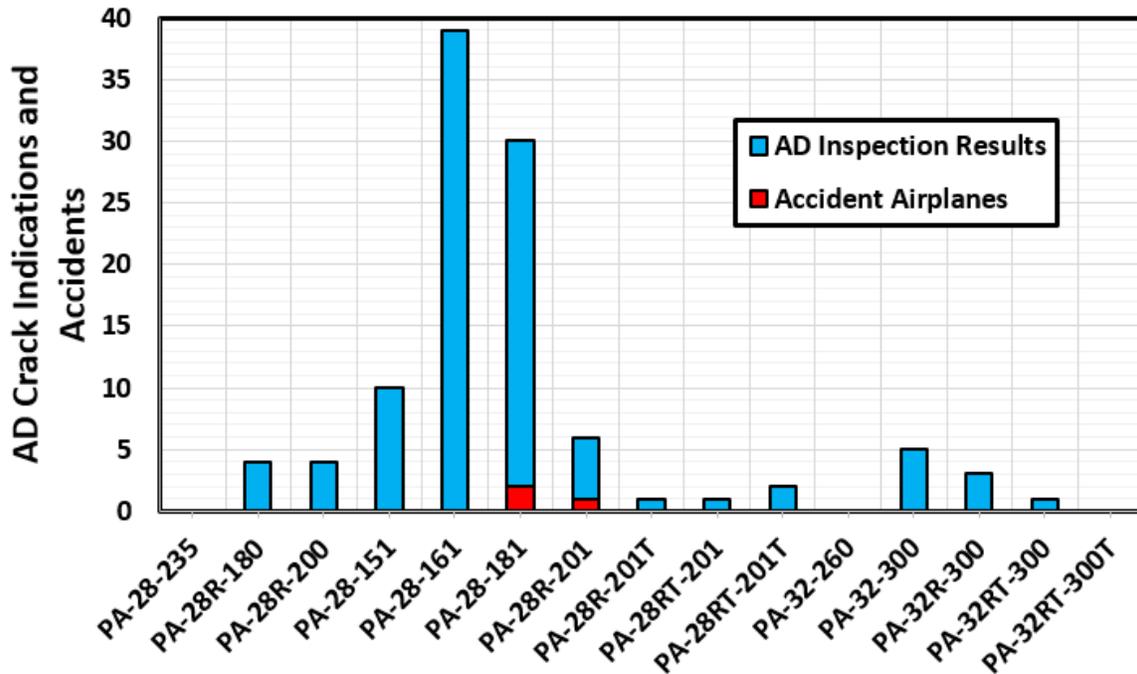
The FAA and Piper received reports on approximately 2,880 airplanes. Out of these, 115 airplanes were reported as having crack indications. Approximately 25 percent of these indications were later confirmed to be hole damage or corrosion and not a crack. The remaining indications include a mix of unconfirmed indications, but fatigue cracks were also identified, including some examples shown in this SAIB. Unconfirmed crack indications were found in airplanes with as little as 3,264 hours time in service (TIS) on a Piper Model PA-28R-180 airplane, but has not yet been confirmed. Figure 3 shows a summary of the positive indication inspection results received by the FAA and airplane models involved in accidents attributed to or potentially related to the spar cracking issue. In addition,

Figure 3. AD Inspection Crack Indications* and Related Accidents

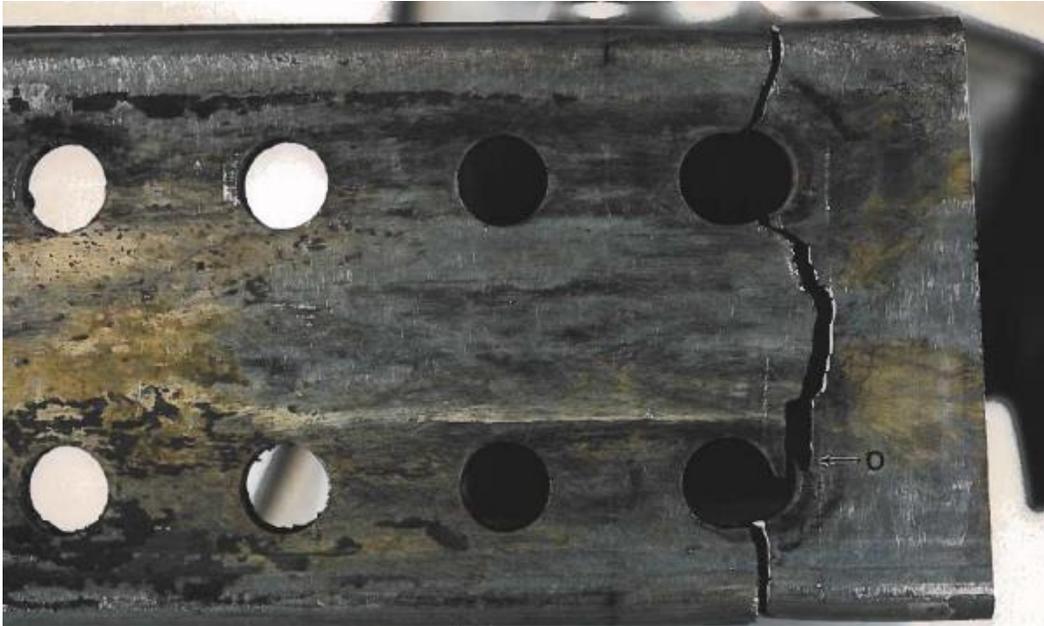
**Figure 4. Example of Cracks Intersecting Outboard Bolt Holes; O indicates crack origin
PA-28-181, 11,600 hours TIS**

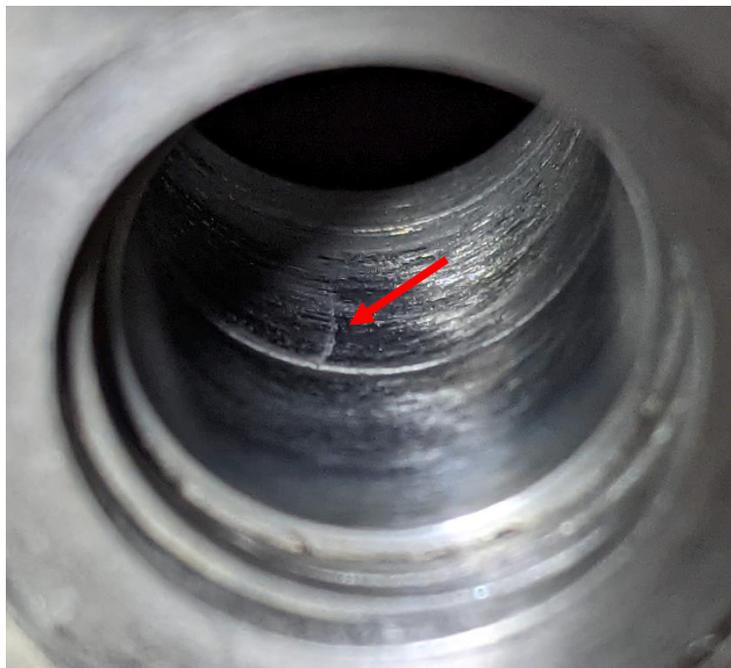
**Figure 5. Example of Cracks Intersecting Bolt Hole, After Corrosion Removal
PA-28-161, 9,036 hours TIS**

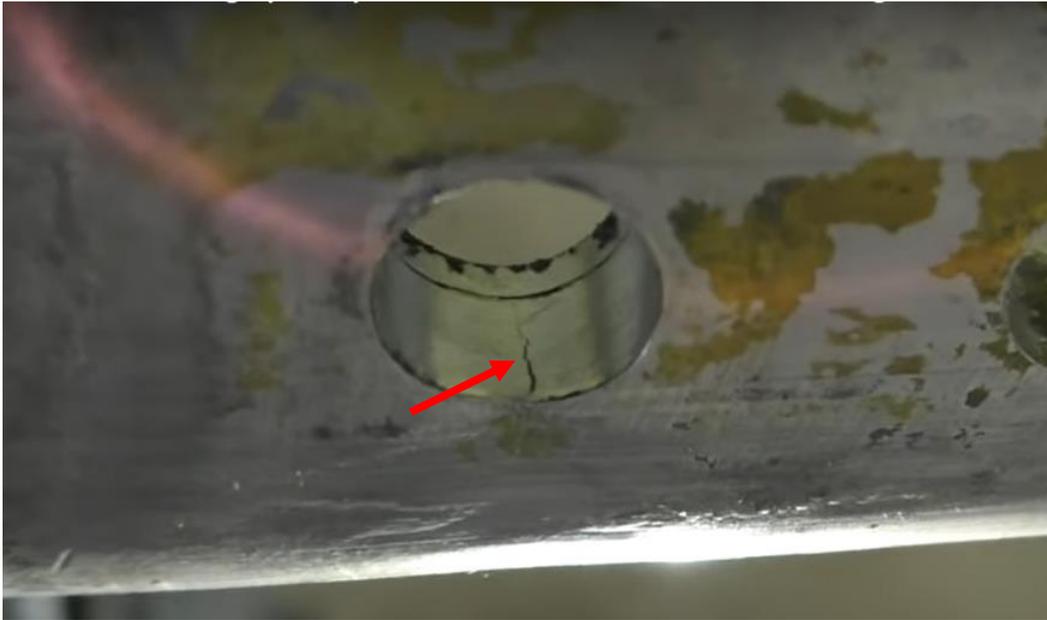
**Figure 6. Example of Cracks Intersecting Bolt Hole
PA-32-300, 5,319 hours TIS**

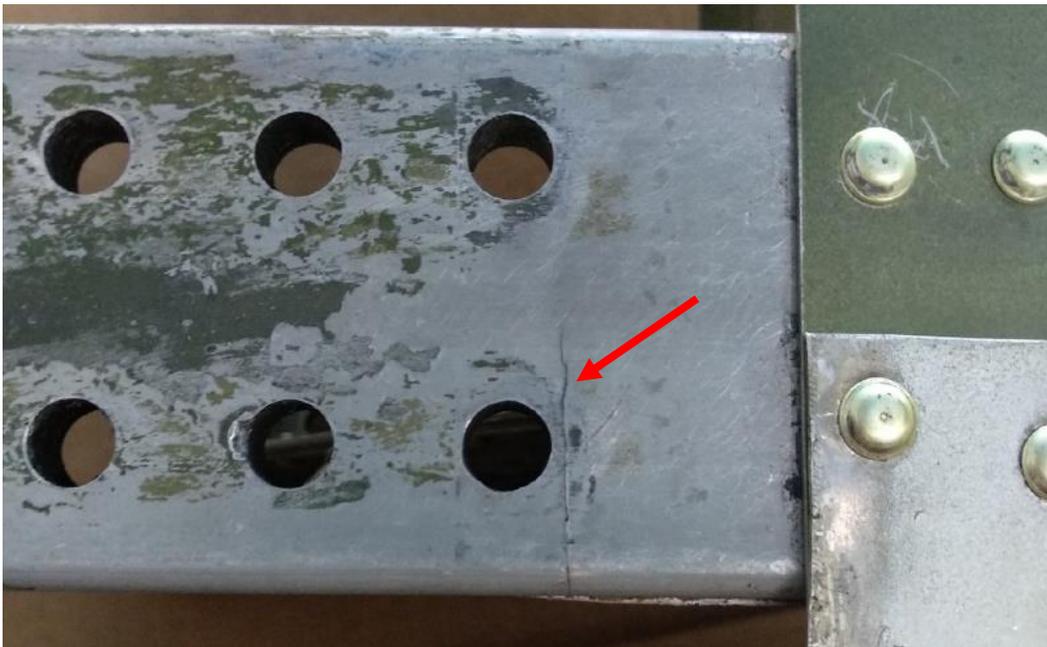
**Figure 7. Example of Cracks Not Intersecting Outboard Bolt Hole
PA-28-181, 12,824 hours TIS**

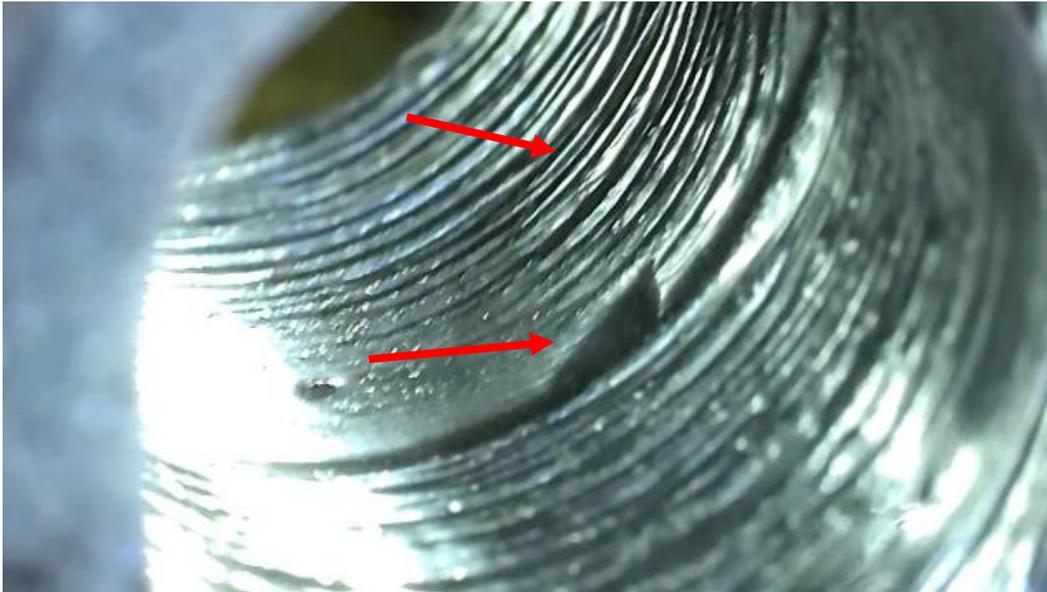
**Figure 8. Example of Mechanical Bolt Hole Damage, No Crack
PA-28-181, 2,533 hours TIS**

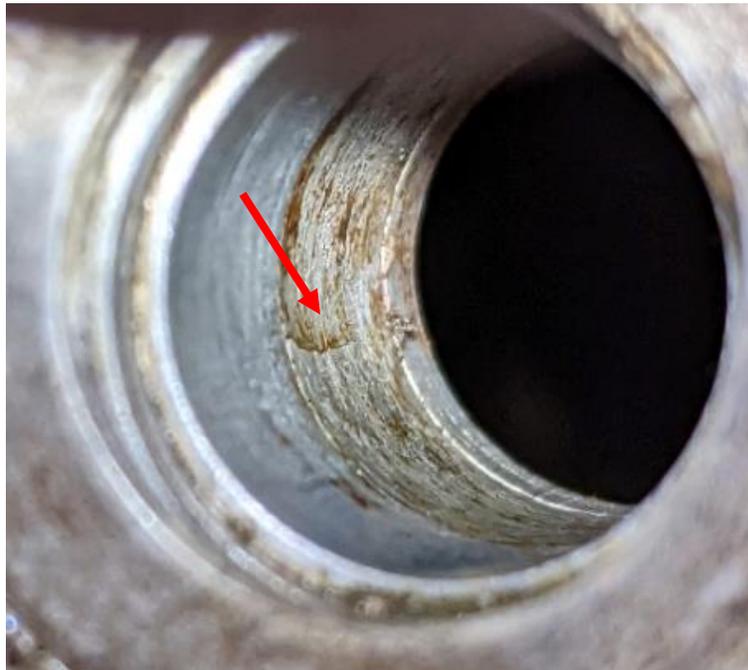
**Figure 9. Example of Corrosion in Bolt Hole, with Crack
PA-28-161, 9,036 hours TIS**

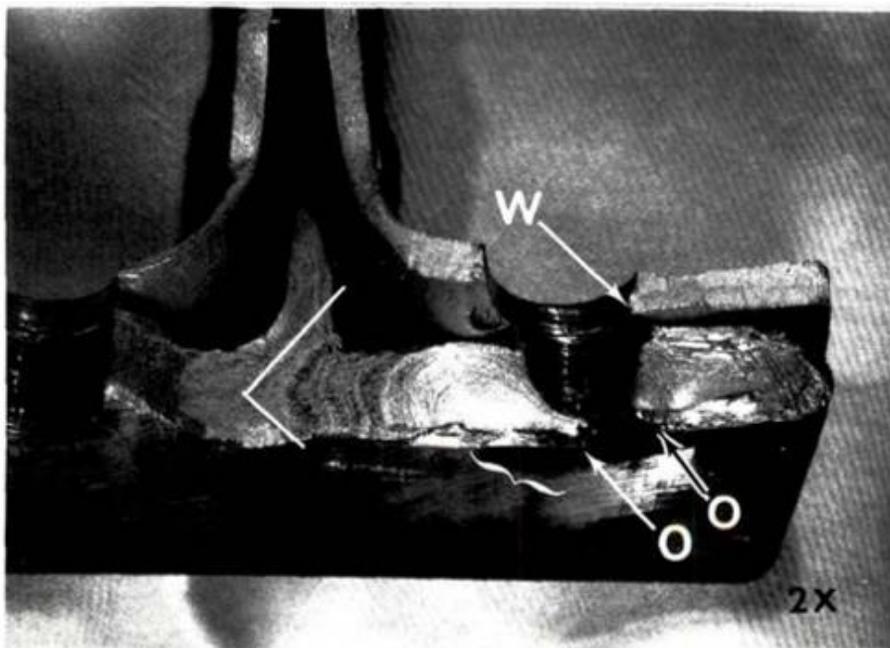
The first related accident occurred in 1987 in Marlin, TX. The accident airplane was a Piper Model PA-28-181 airplane with 7,490 hours TIS. Nearly all of this airplane's flight time was known to be spent in a "Pipeline Patrol" mission. This type of mission is characterized by very low altitude and terrain following flight profiles. These flying characteristics degrade an aircraft's structure faster than most other missions. See Figure 10 for a view of the accident airplane's failed spar, where "O" indicates fatigue crack origins and "W" indicates a web fatigue crack.

**Figure 10. 1987 Accident, Failed Wing Spar
PA-28-181, 7,490 hours TIS; O indicates crack origin**

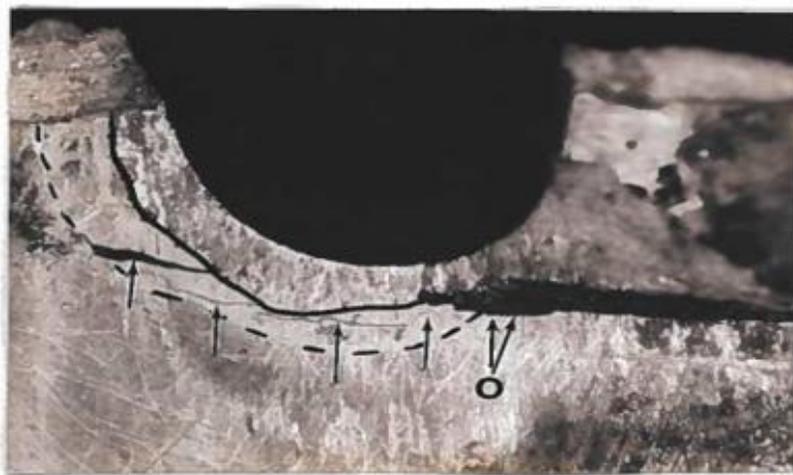
The second of these accidents occurred in 1993 in Provincetown, MA. The accident airplane was a Piper Model PA-28-181 airplane with 11,683 hours TIS. This accident was attributed to weather with signs of structural overloading, but a fatigue crack was also found in the failed spar. The crack is beyond the critical crack size later calculated for that spar. While the NTSB did not identify the fatigue crack as the probable cause of the accident, its presence may have contributed to the effect of the structural overload. At the time of the accident, the airplane was being flown for personal use; however, the airplane was operated by a company providing a mix of training and charter flights. The training mission type of flying is characterized by low altitudes and many takeoff and landing cycles. While less severe than a “Pipeline Patrol” mission, the training mission would contribute more towards fatigue than personal use. See Figure 11 for a view of the accident airplane’s failed spar near a bolt hole, where “O” indicates fatigue crack origins. The origin in this case was adjacent to the hole, not in the hole, as in the 2018 accident.

**Figure 11. 1993 Accident, Failed Wing Spar
PA-28-181, 11,683 hours TIS; O indicates crack origin adjacent to the bolt hole**

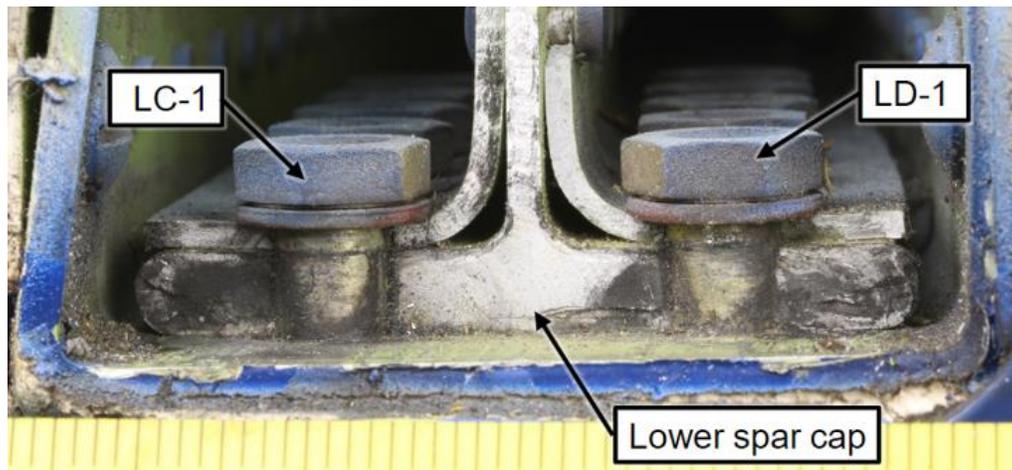
The third and most recent of these accidents occurred in 2018 in Daytona Beach, FL. The accident airplane was a Piper Model PA-28R-201 airplane with 7,691 hours TIS. This airplane was used almost exclusively for flight training throughout its lifetime. This type of usage is expected to reduce the fatigue life of the airplane more than an airplane used as a mixture of personal and training, while still less damaging than use exclusively in the “Pipeline Patrol” mission. See Figure 12 for a view of the accident airplane’s failed spar.

**Figure 12. 2018 Accident, Failed Wing Spar
PA-28R-201, 7,691 hours TIS**
