# AG-CAT SERVICE NOTES and BULLETINS

**GRUMMAN** AMERICAN AVIATION  
CORPORATION

AG-CAT SERVICE BULLETINS

## SERVICE BULLETIN INDEX

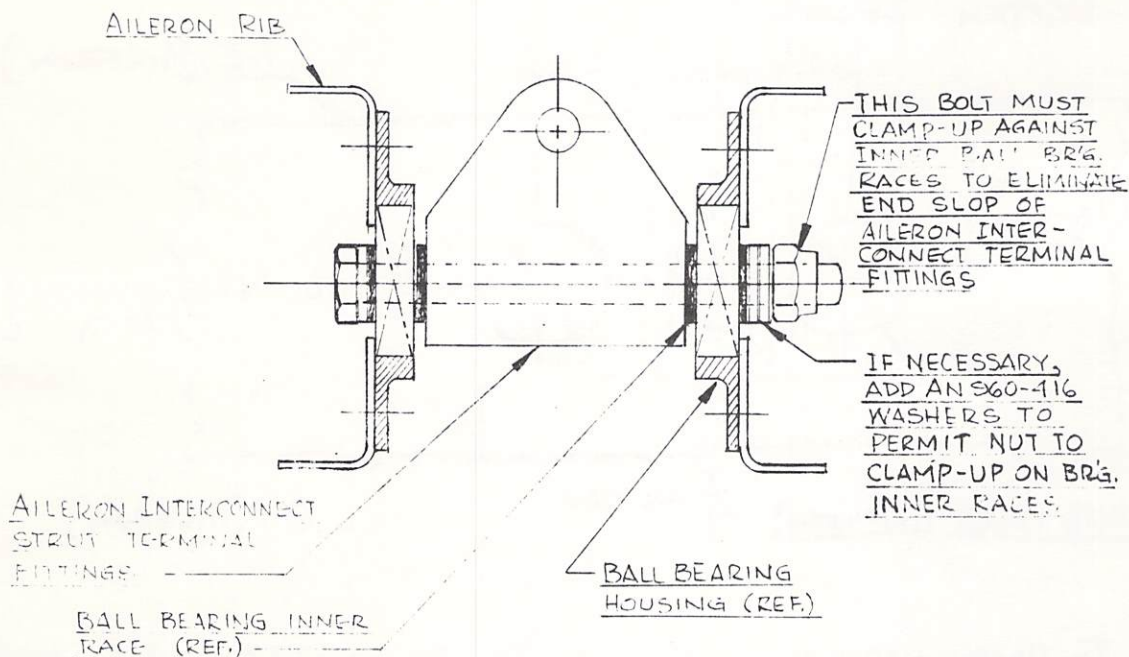
1. Add two (2) each of P/N A1004-35 and -33 (inspection hole metal inspection cover plates and commercial celluloid grommets) per attached E.C.O. #S164-528 to obtain visual and mechanical access to the aileron interconnect attach bolt connection. Inspection of this interconnect terminal connection may indicate that the thru bolt is not firmly clamped up on the inner races of the ball bearings as it should be.

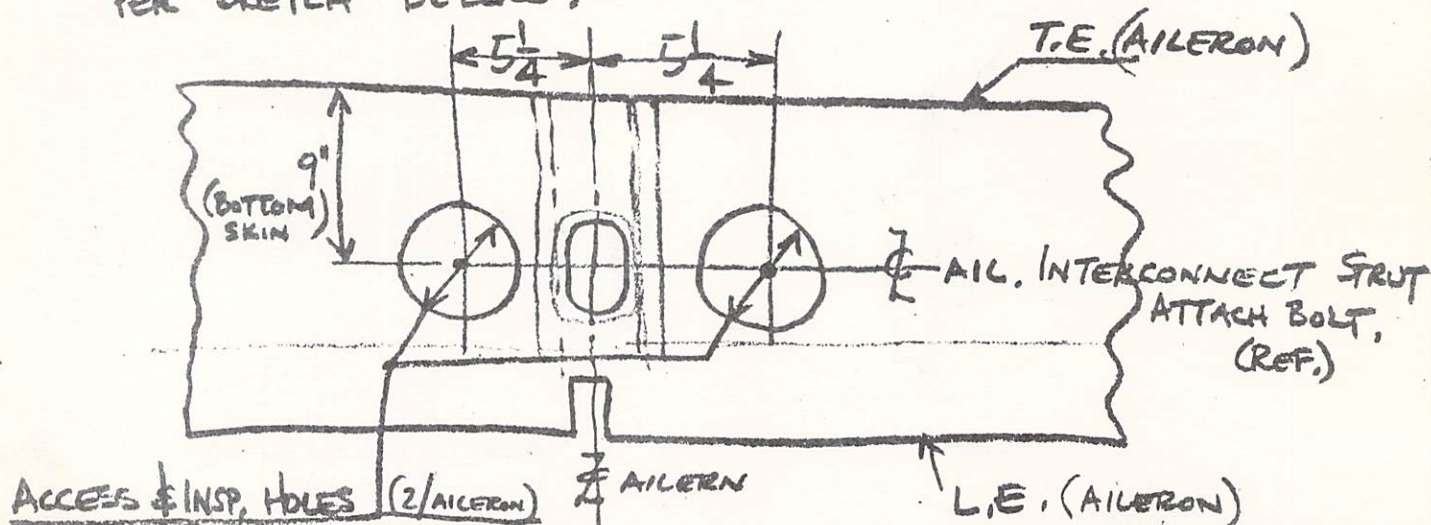
- ① TO HAVE INSPECTION ACCESS TO AIL. INTERCONNECT ATTACH BOLT CONNECTION. (NO BACK FITTING! CONVENIENCE ITEM ONLY.)

CHANGE: ① ADD TWO EA. of P/N A1004-35 & -33, INSPECTION HOLE METAL INSPECTION COVER PLATES ( $4\frac{5}{8}$ " O.D. SINGLE SPRING TYPE) & COMM'L CELLULOID GROMMETS ( $3\frac{1}{2}$ " I.D. x  $4\frac{5}{8}$ " O.D.) TO THE UNDER SIDE FABRIC COVER ASSY (A1131) PER DETAIL of INSTALL. SHOWN ON DWG A1004 (SECTION J-I) & LOCATED ON AILERON COVER FABRIC ASSY AS PER SKETCH BELOW :-

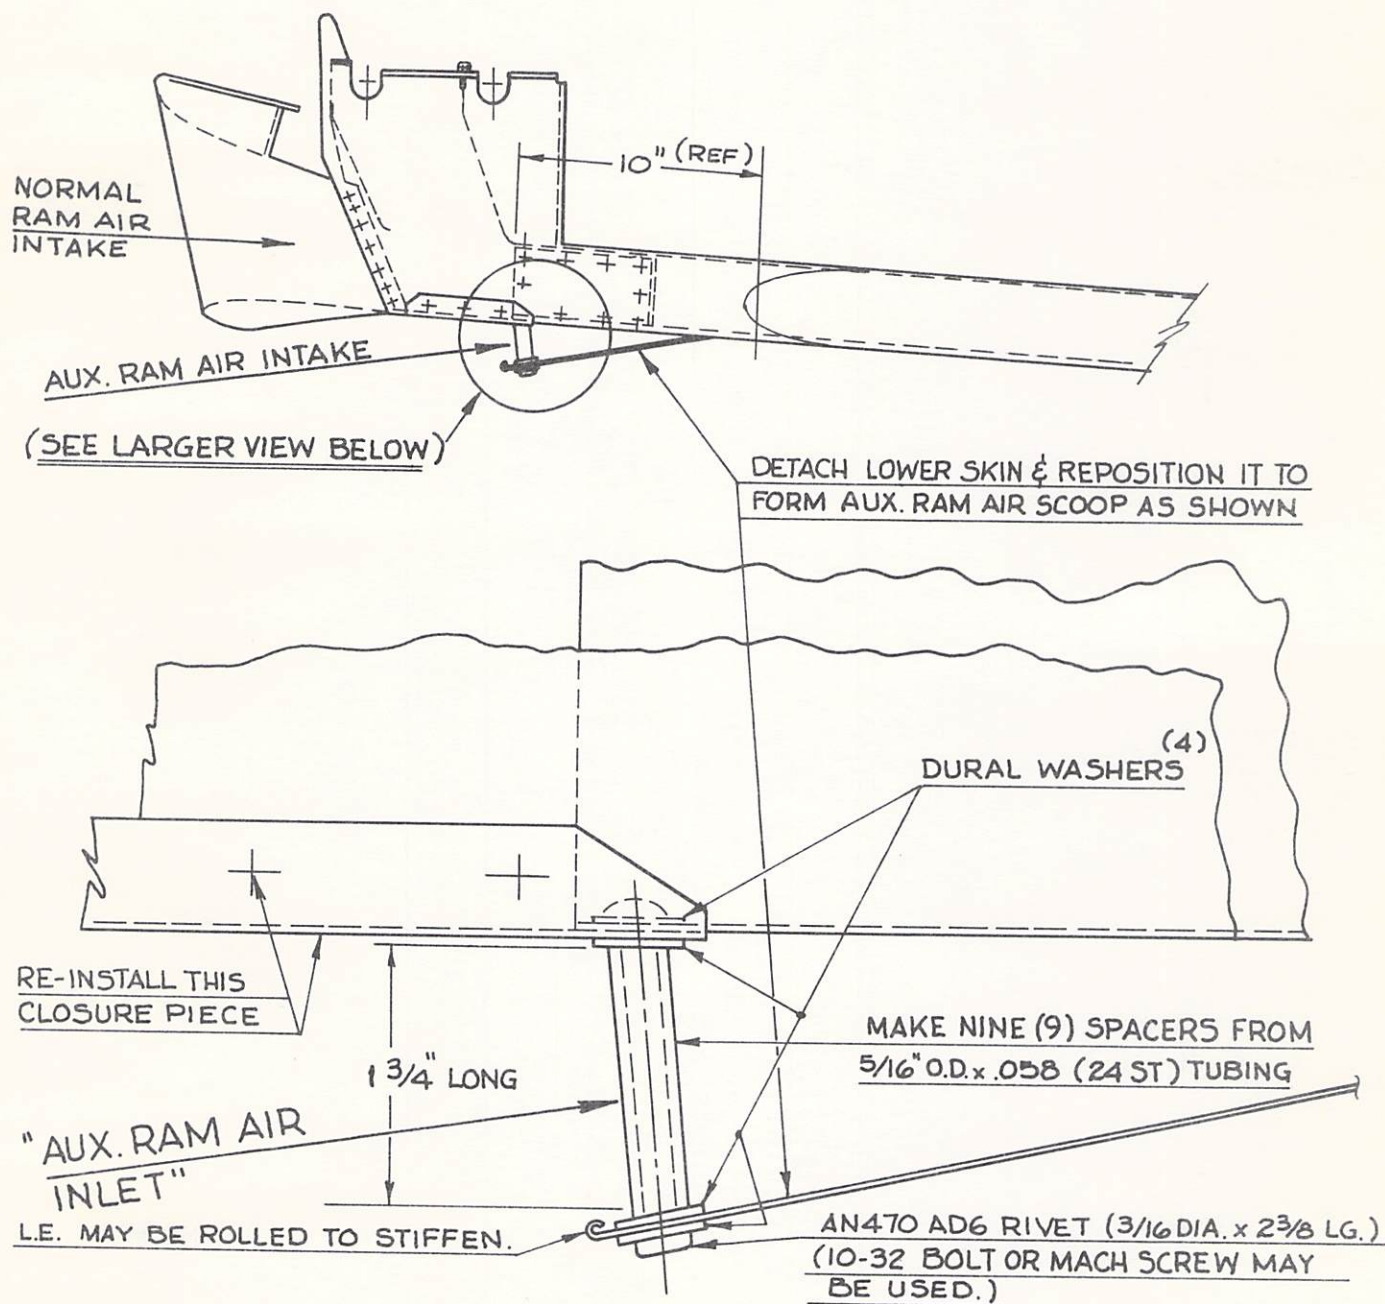
Note: This modification is not mandatory, nor does it consume much effort, but the swath width is improved approx. 50% & the distribution of solids is considerably better.

1. Refer to sketch for spreader modification details: -

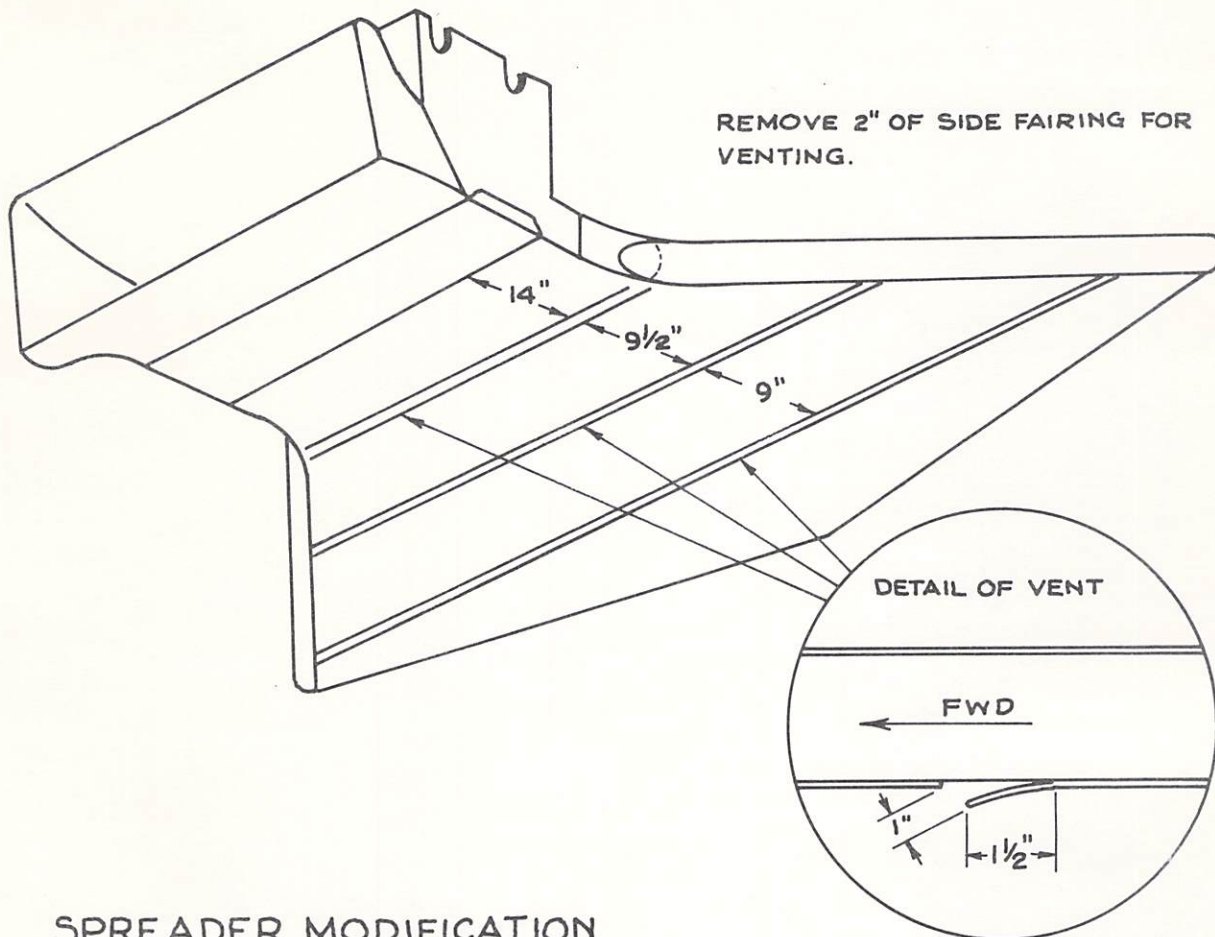
BULLETIN # 5

THIS MODIFICATION PRODUCES A MUCH BETTER MIXING OF LIGHT DUSTS AND SHOWS EXCELLENT SHUT OFF CHARACTERISTICS. IT IS HIGHLY RECOMMENDED FOR THOSE OPERATORS ENGAGED IN HEAVY DUSTING OPERATIONS.

## SPREADER MODIFICATION

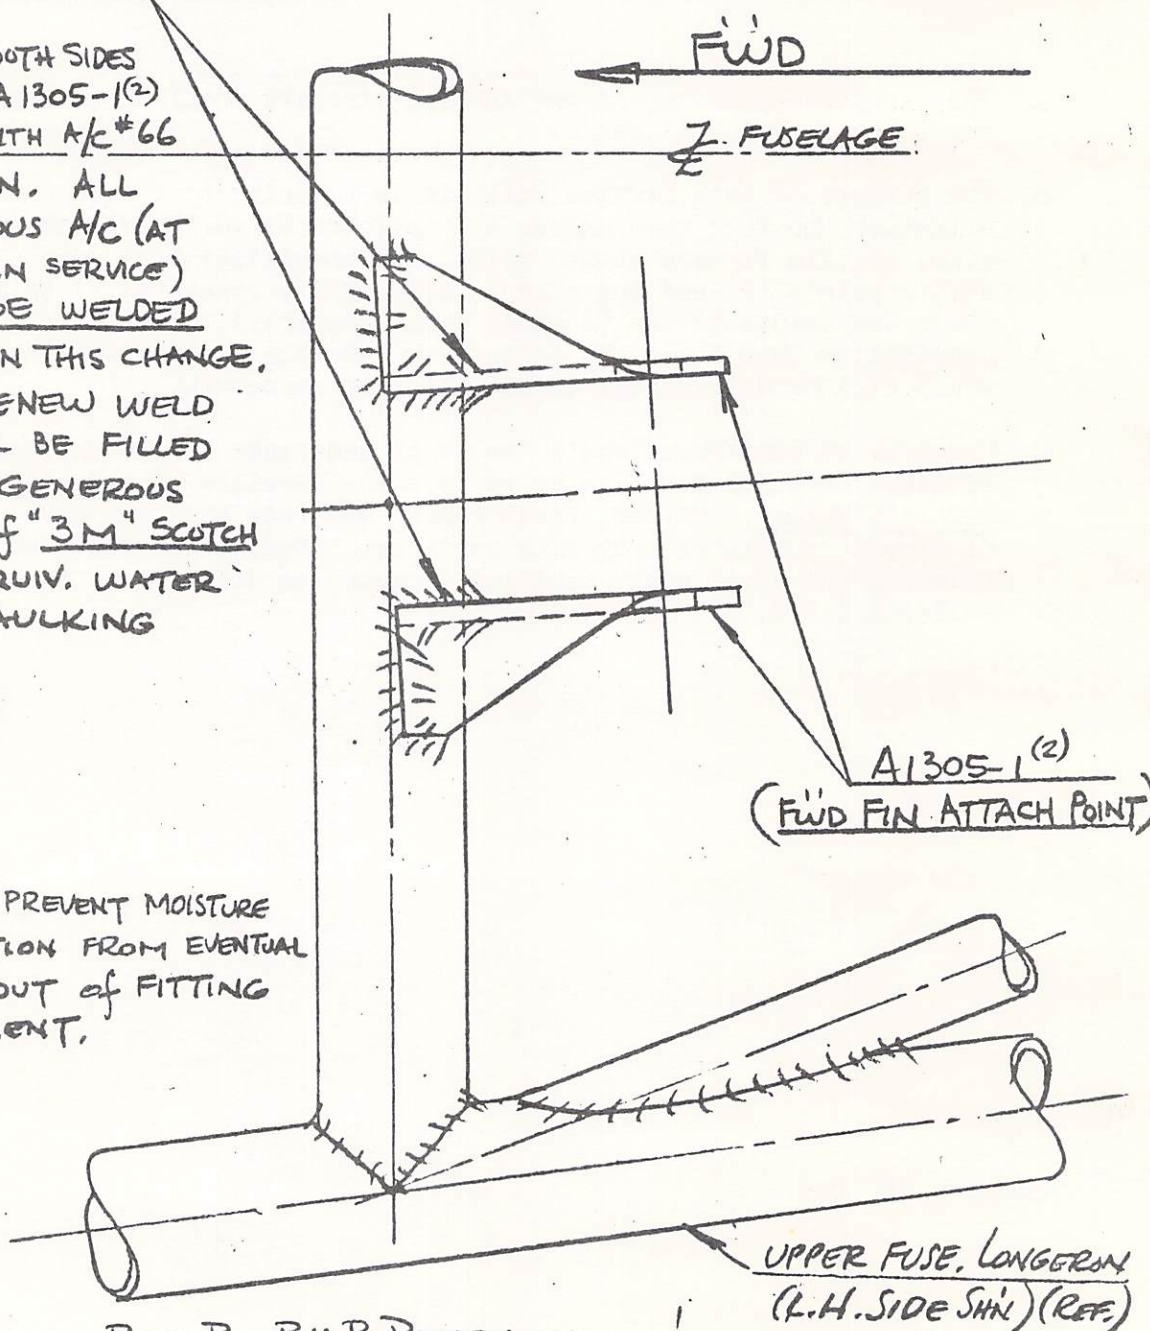
REASON: ① TO PREVENT MOISTURE ACCUMULATION FROM EVENTUAL RUSTING-OUT OF FITTING ATTACHMENT.

1. The corrosion-proofing of the subject aircraft shall be undertaken per the attached enclosures.
2. The purpose of this Service Bulletin is to bring to the owner's attention the fact that unless the enclosed E.C.O.'s are complied with, the fin forward attach point, the stabilizer rear spar attach points (2) and the rubber cable pulley brackets (2) (all three are welded to the fuselage frame assembly), there is a good possibility that corrosive action may take place at these fittings which will be detrimental to the aircraft structure.
3. Under no circumstances shall the owner undertake to rework these fittings by welding unless he employs the services of a Certified Aircraft Welder. Rather, first remove any rust that may have developed in this area by wire brushing. Then, after touch-up painting the area, apply caulking compound as directed on the enclosed E.C.O.'s.

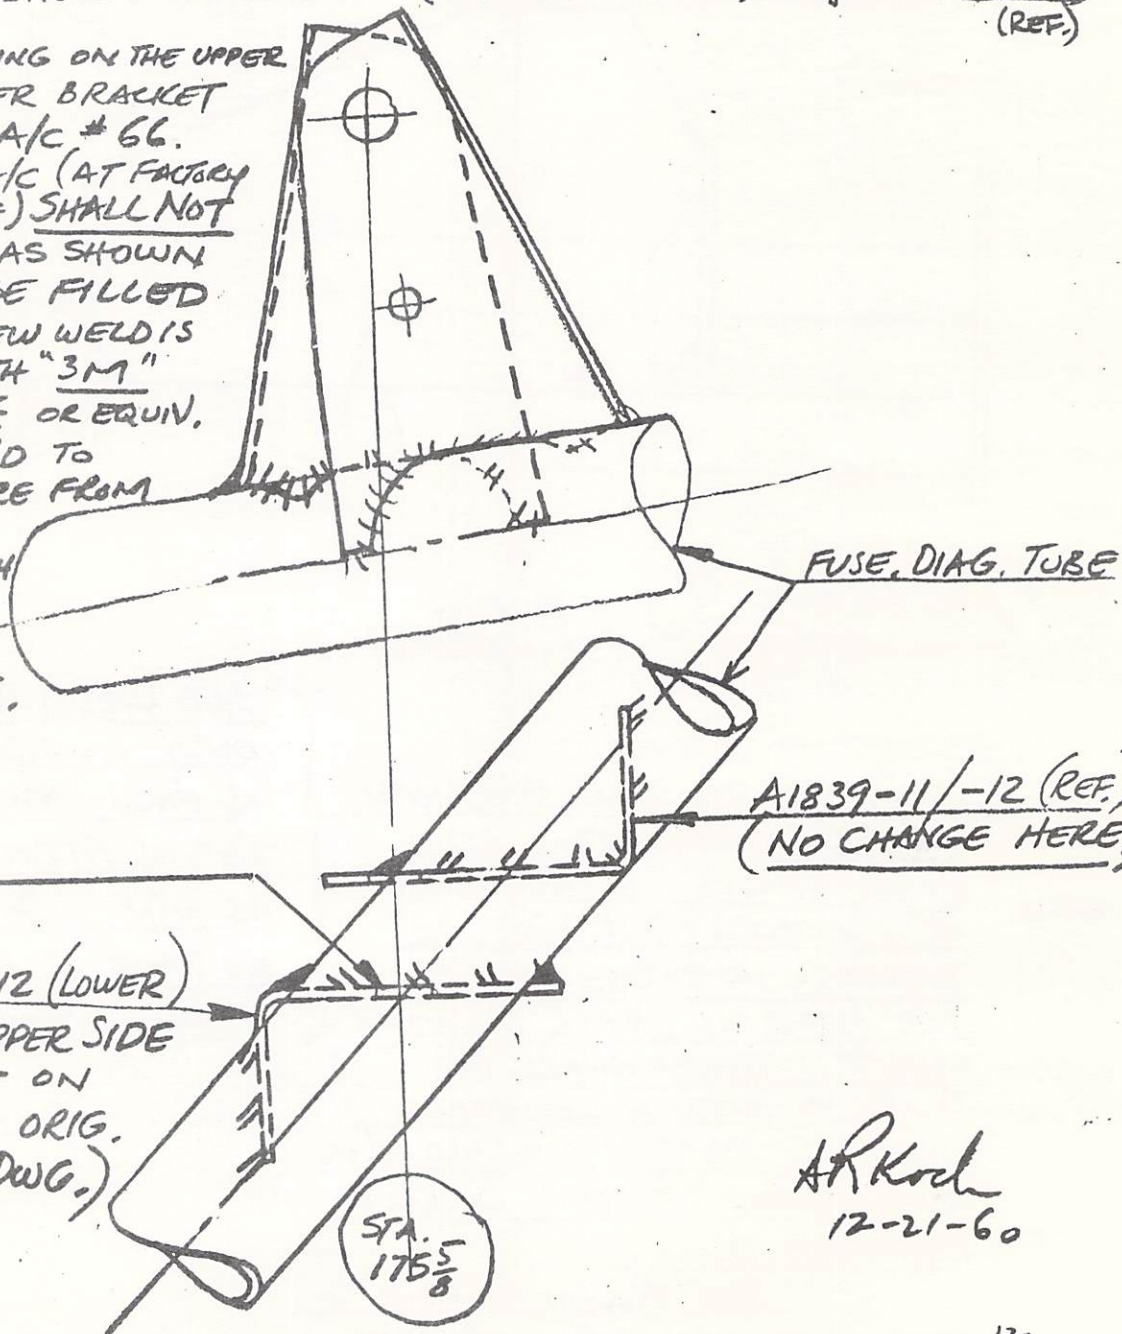
CAULKING COMP'D TO PREVENT MOISTURE FROM DEPOSITING IN THIS AREA WHICH COULD CAUSE CORROSION OF THE FUSE, TUBE.

② START WELDING ON THE UPPER SIDE OF LOWER BRACKET IN PROD. ON A/C #66. ALL OTHER A/C (AT FACTORY OR IN SERVICE) SHALL NOT BE RE-WELDED AS SHOWN BUT SHALL BE FILLED IN WHERE NEW WELD IS INDICATED WITH "3M" SCOTCH CAULK OR EQUIV.

A1839-11/-12 (LOWER) WELD ON UPPER SIDE ONLY; NOT ON BOTTOM AS ORIG. SHOWN ON DWG.)

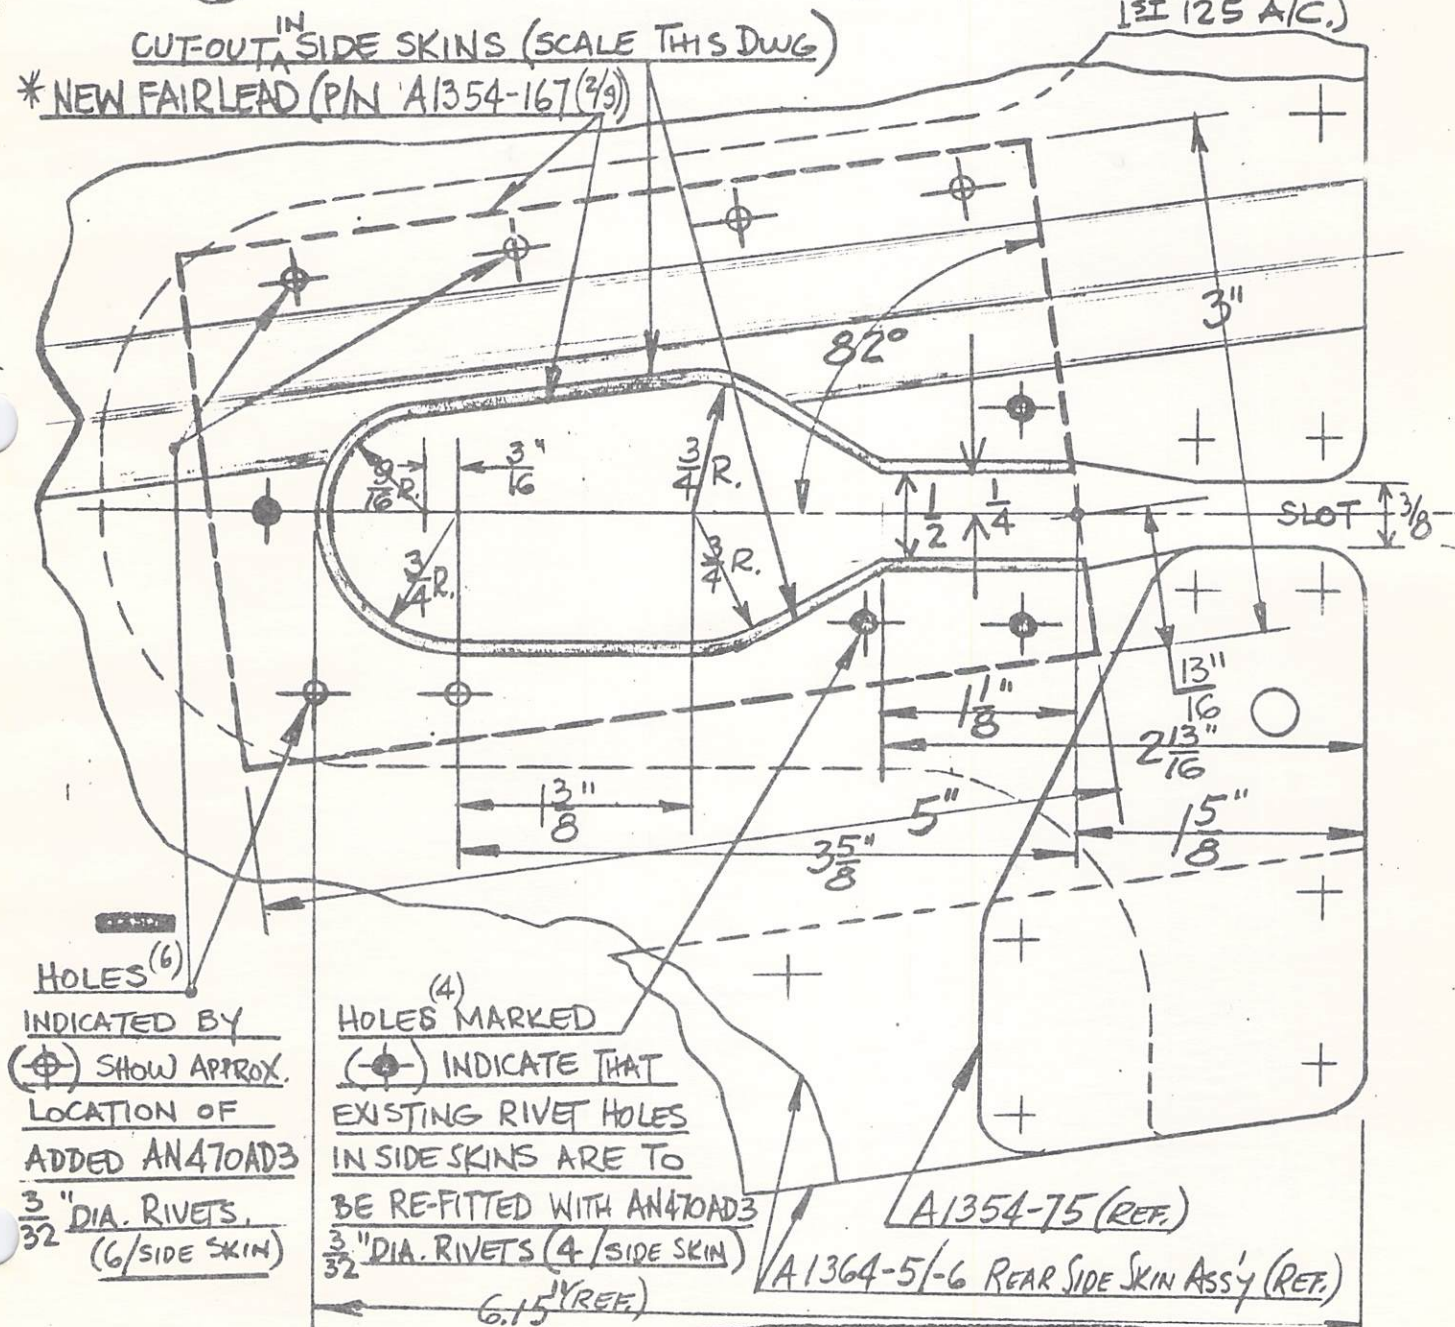
SUBJECT: Wear on Elevator and Rudder Cables, Where They Pass Through the Dust Seal Bulkhead, and Where Rudder Cables Pass Through Fuselage Side Skin Fairing Fairlead Slots Just Forward of the Rudder Horn

HOLES (6) /  
INDICATED BY  
(Φ) SHOW APPROX.  
LOCATION OF  
ADDED AN470AD3  
3/32" DIA. RIVETS.  
(6/SIDE SKIN)

(4)  
HOLES MARKED  
(-●-) INDICATE THAT  
EXISTING RIVET HOLES  
IN SIDE SKINS ARE TO  
BE RE-FITTED WITH AN470AD3  
3/32" DIA. RIVETS (4 / SIDE SKIN)  
6.15" (REF.)

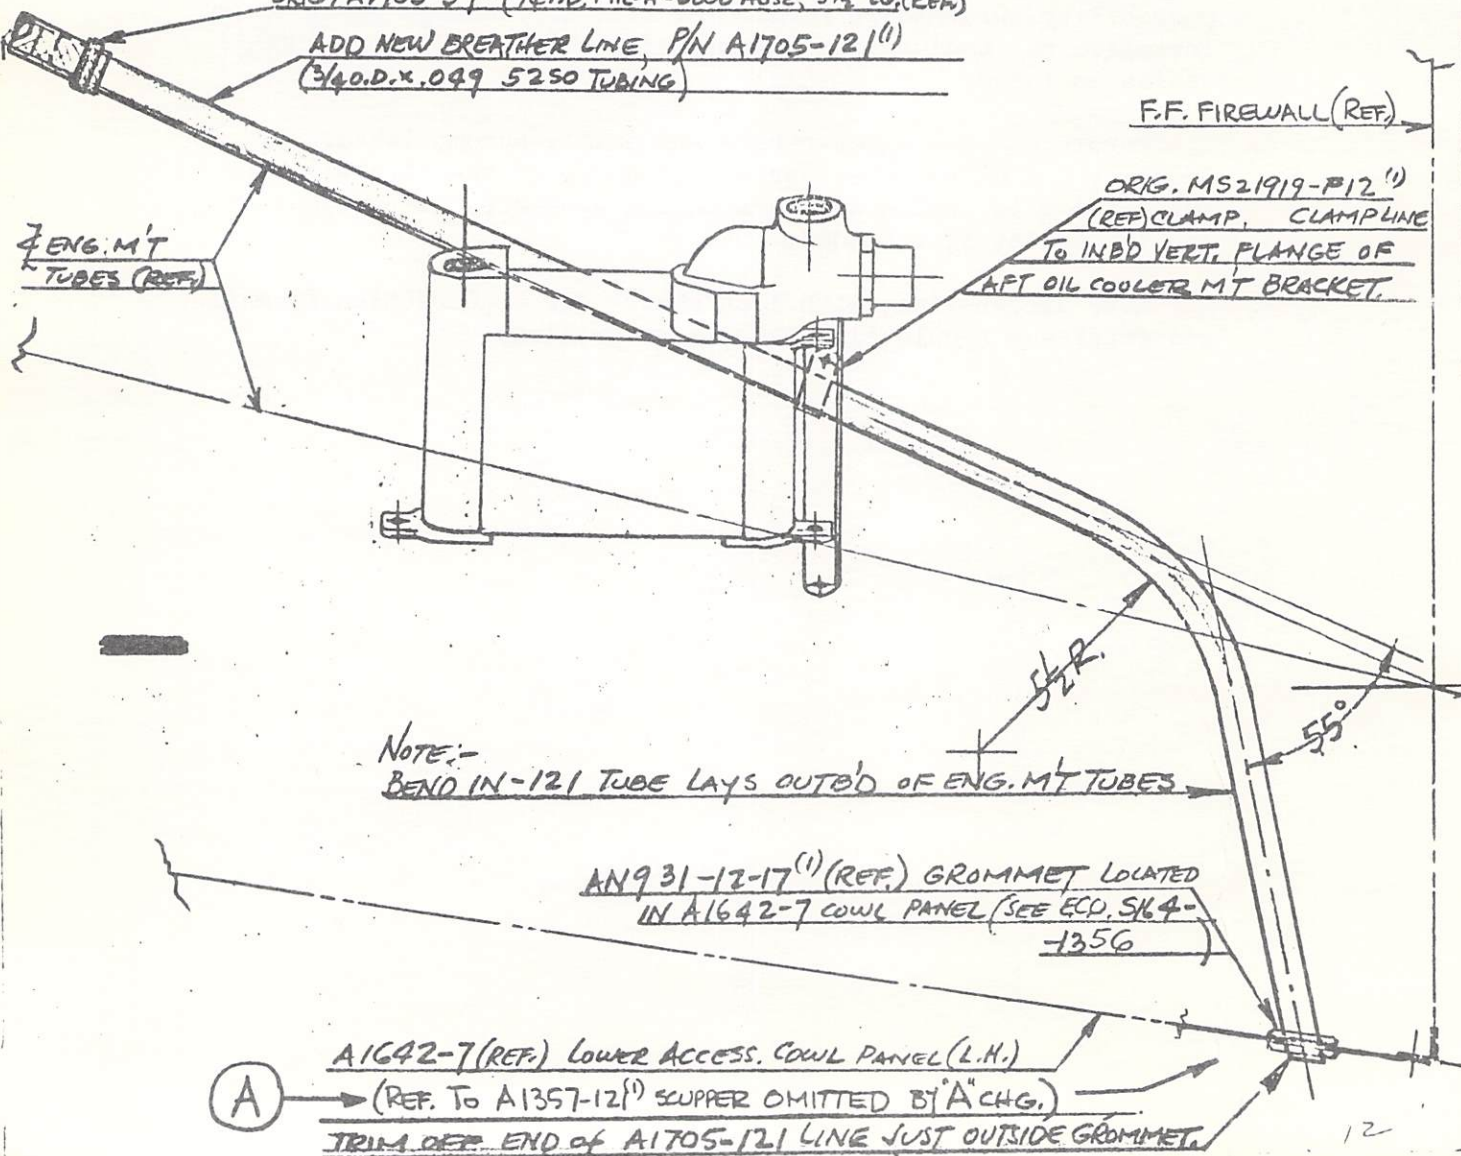
"B" CHG:- REMOVE P/N A1357-121<sup>(1)</sup>  
SCUPPER FROM CHG "A".  
OMISSION OF SCUPPER MAKES  
INSTALL. LESS LIABLE TO ICING UP.  
A.R.Koch 1-22-64

ADD NEW BREATHER LINE P/N A1705-121<sup>(1)</sup>  
(3/40.D.X.049 5250 TUBING)

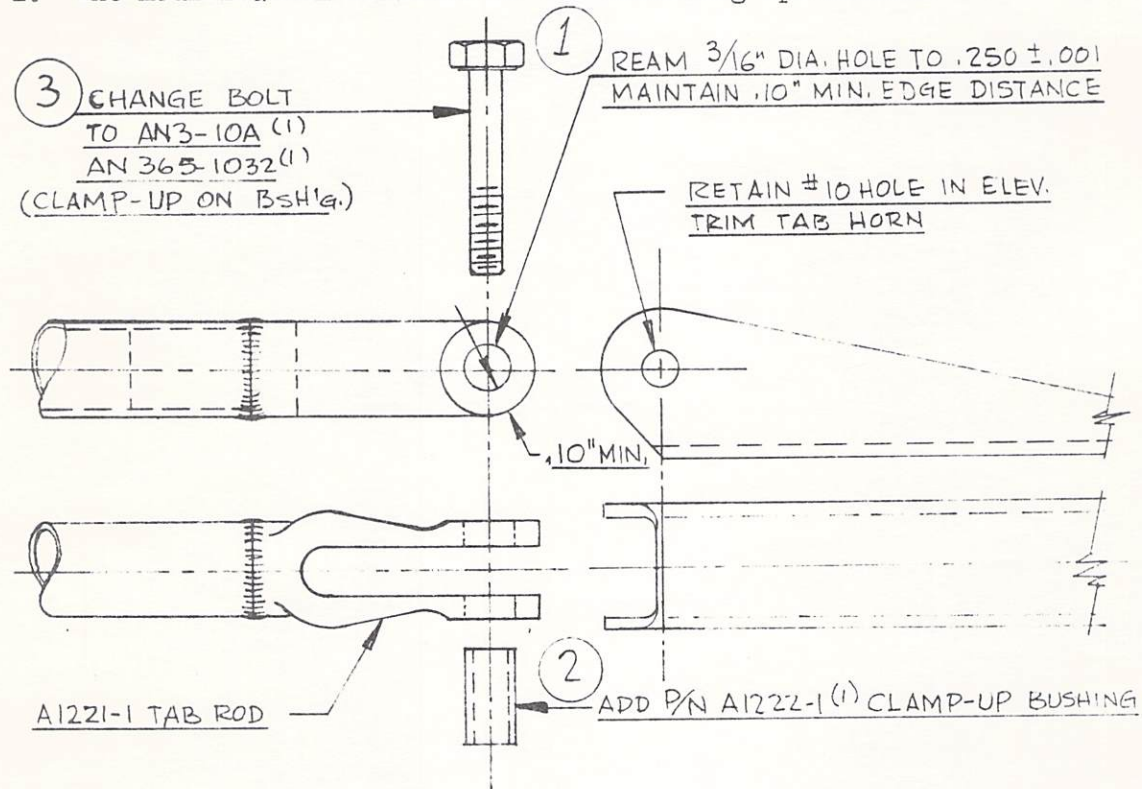
1. Starting with production Ag-Cat Serial No. 275, we have modified the design of the subject trim tab horn connection to give longer service life by increasing the bearing surface area of the bolted connection. Ag-Cats manufactured prior to S/N 275 may be (optional) modified to conform with this improved design detail. As noted below, very little work is involved to make the modification, and the results to be gained are considerable.
2. The modification consists of the following operations:

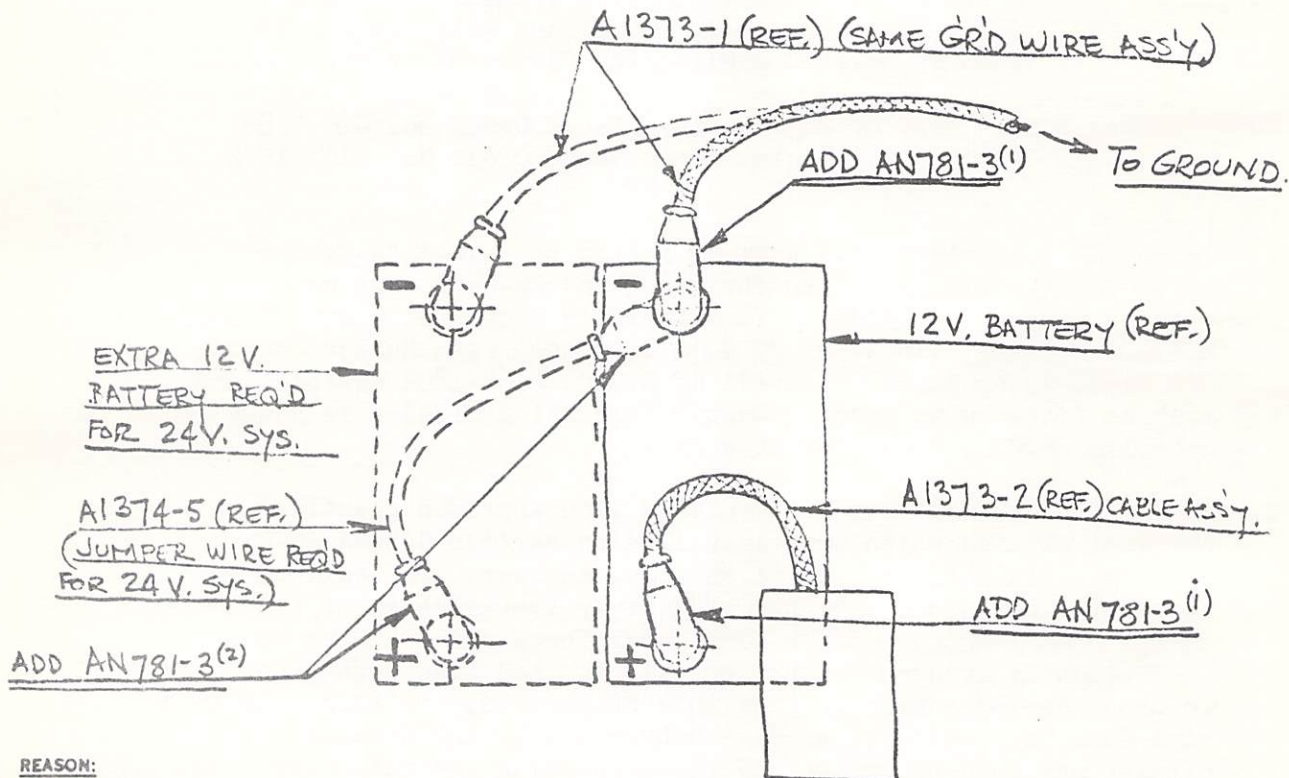
- ① TO PROVIDE ADDITIONAL TERMINAL INSULATION AGAINST GROUNDING.

- ① ADD EITHER TWO (2) OR FOUR (4) AN 781-3 INSULATING NIPPLES, ELECTRICAL TERMINAL TYPE, TO 12VOLT OR 24V. BATTERY TERMINAL LEADS AS SHOWN BELOW IN SKETCH FORM:—

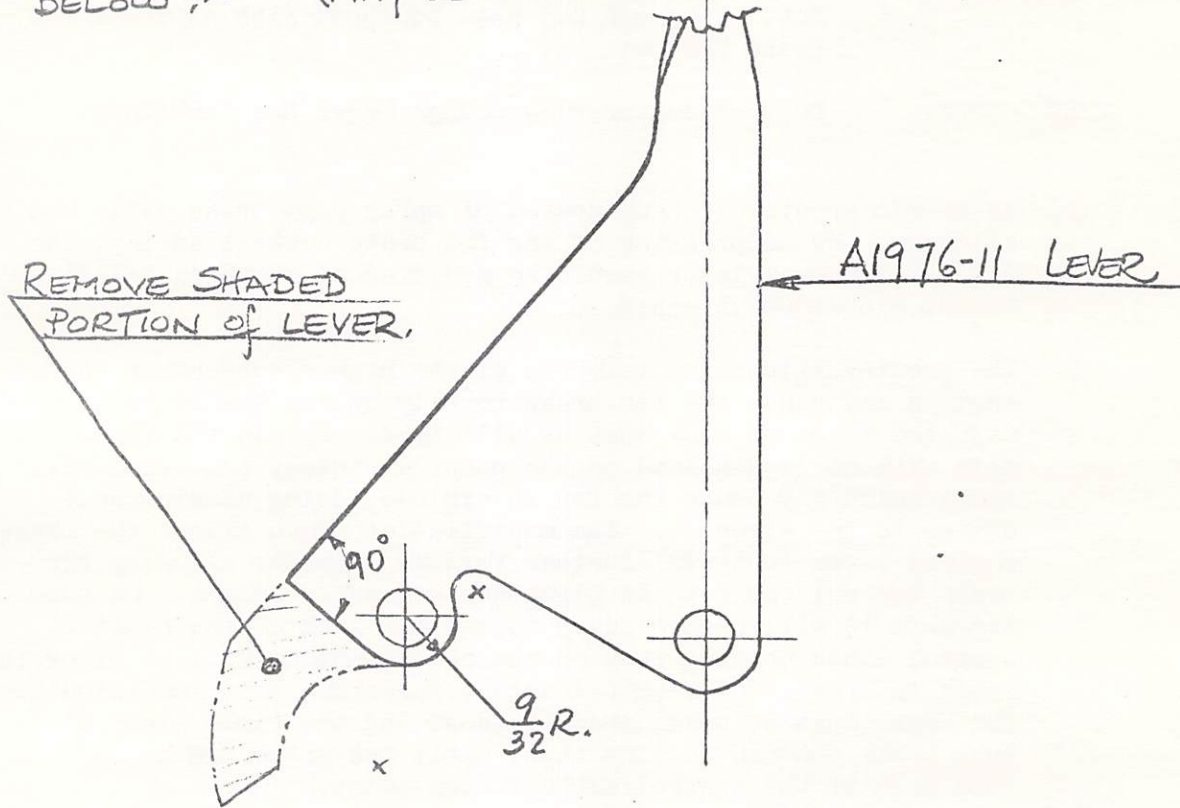
1. TO PERMIT GREATER LOCK-UP TRAVEL of BRAKE CABLE.

1. CUT OFF STOP PORTION of -11 LEVER AS DETAILED BELOW;— (MAY BE BACK-FITTED ON ALL A/C)

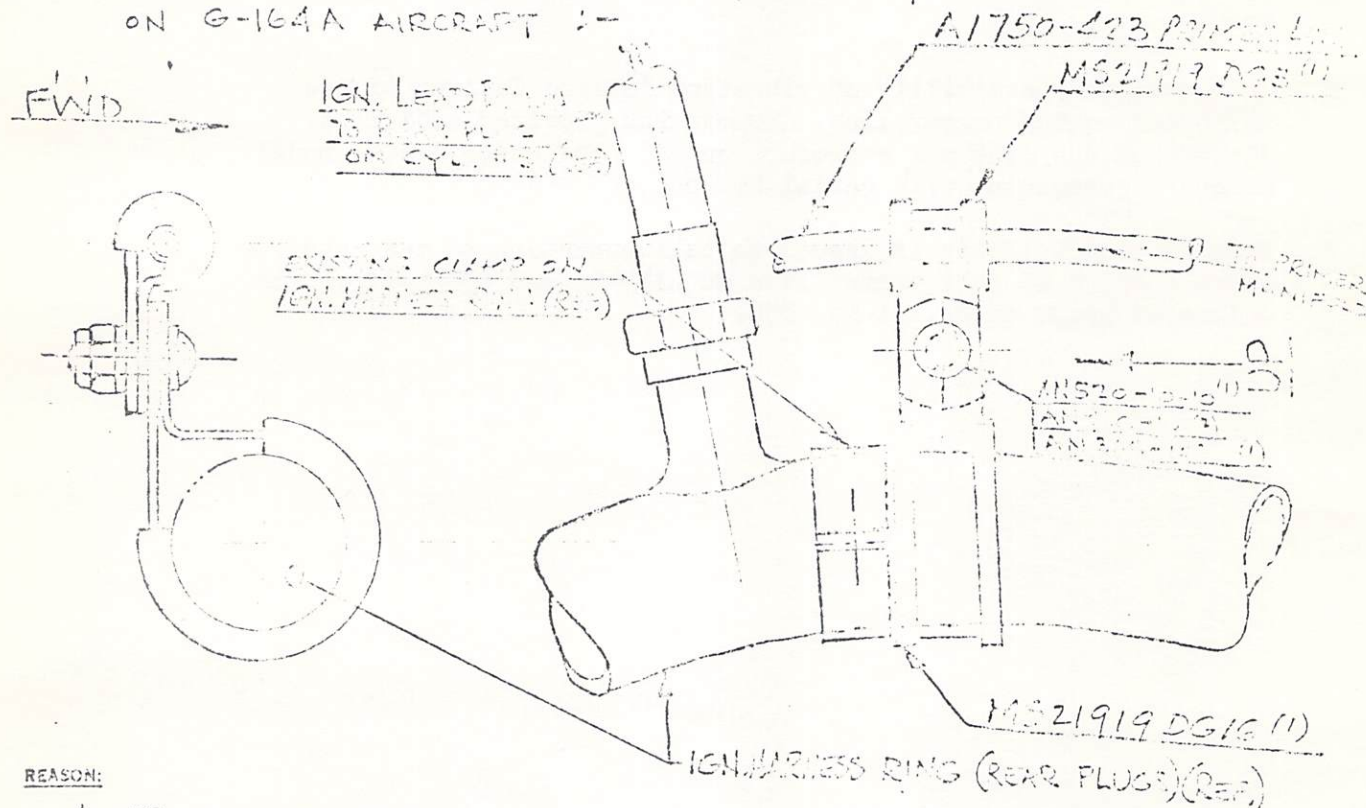
1. TO PROVIDE ADDED SUPPORT AGAINST VIBRATION TO THE PRIMER LINE APPROX MID-WAY BETWEEN THE ENGINE MTD PRIMER MANIFOLD & THE ELKED FITTING IN THE PRIMER LINE @ THE ENGINE BAFFLE.

1. STARTING IN PRODUCTION ON A/C S/N 856, CLAMP A1750-423 PRIMER LINE TO THE IGNITION HARNESS RING JUST BELOW THE IGNITION LEAD <sup>BRANCH</sup> FOR THE REAR SPARK PLUG OF #9 CYLINDER AS SHOWN BELOW FOR ALL 450 & 600 h.p. ENGINE INSTALLATION, ON G-164A AIRCRAFT :-

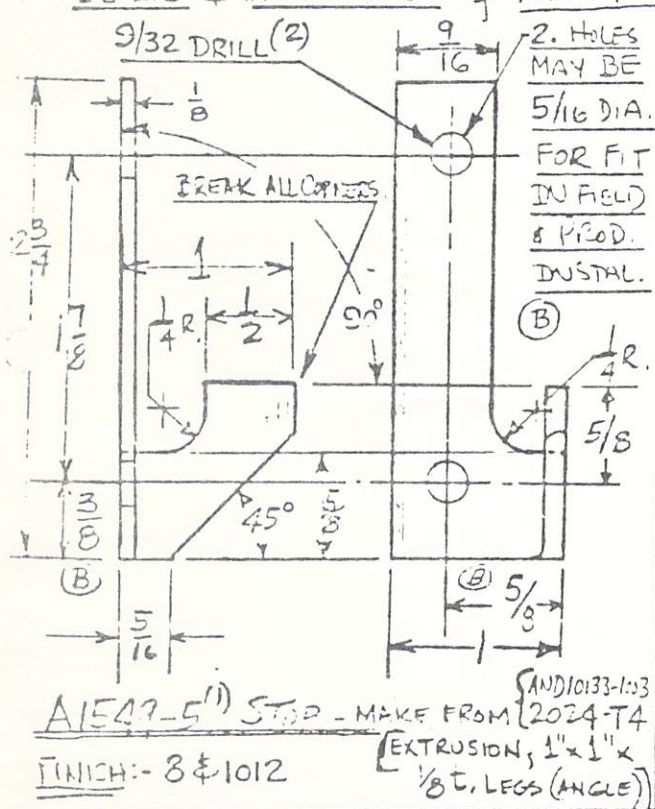
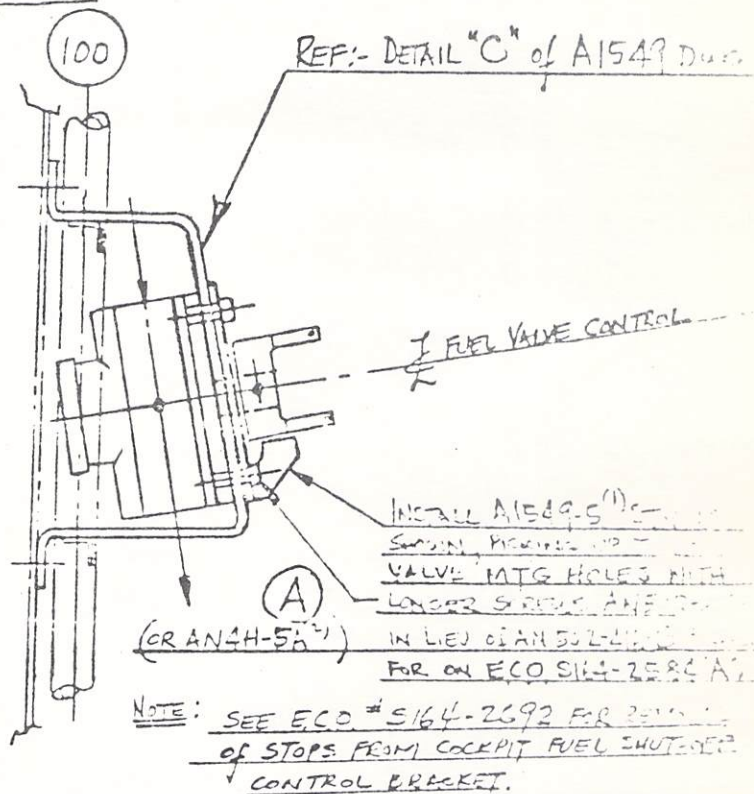
1. TO MOVE STOPS FROM COCKPIT CONTROL HANDLE TO VALVE FOR POSITIVE POSITIONING OF VALVE.
2. TO ACCOMMODATE FIELD INSTALLATIONS & PRODUCTION VARIATIONS.

CHANGE: 1. ADD A1549-5<sup>(1)</sup> (STOP) TO A1747-1 (3/4" P.T. PORT VALVE INSTALL. 5/8" D. GRAVITY-FLOW FUEL SYSTEM) AS SHOWN ON DETAIL "C" OF DWG A1549.

DETAIL & INSTALLATION OF A1549-5<sup>(1)</sup> STOP SHALL BE AS SHN BELOW:

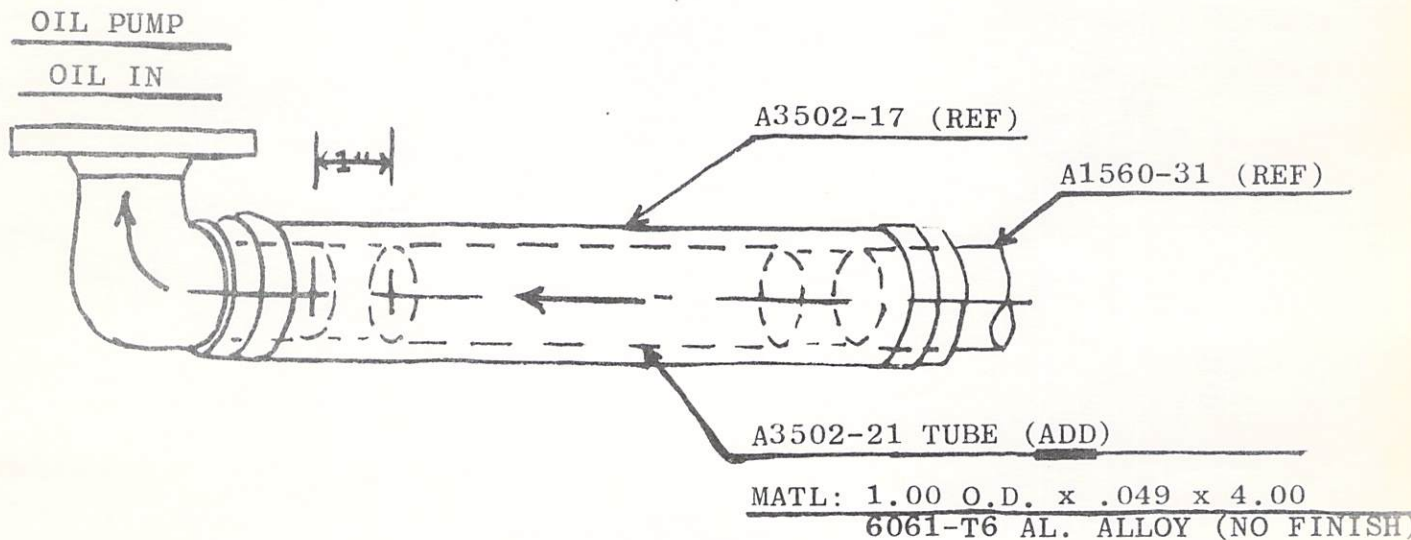
Due to the oil inlet hose (P/N A3502-17) installed on all "B" Grumman American Ag-Cats being longer in relation to the longer engine mount, a condition could possibly exist whereby this hose could collapse because of oil pump suction pressure.

Although there has not been any reported incidence relating to this condition, we highly recommend that, within the next 25 hours of operation, the aluminum reinforcement tube (P/N A3502-21) be installed in accordance with the drawing below.

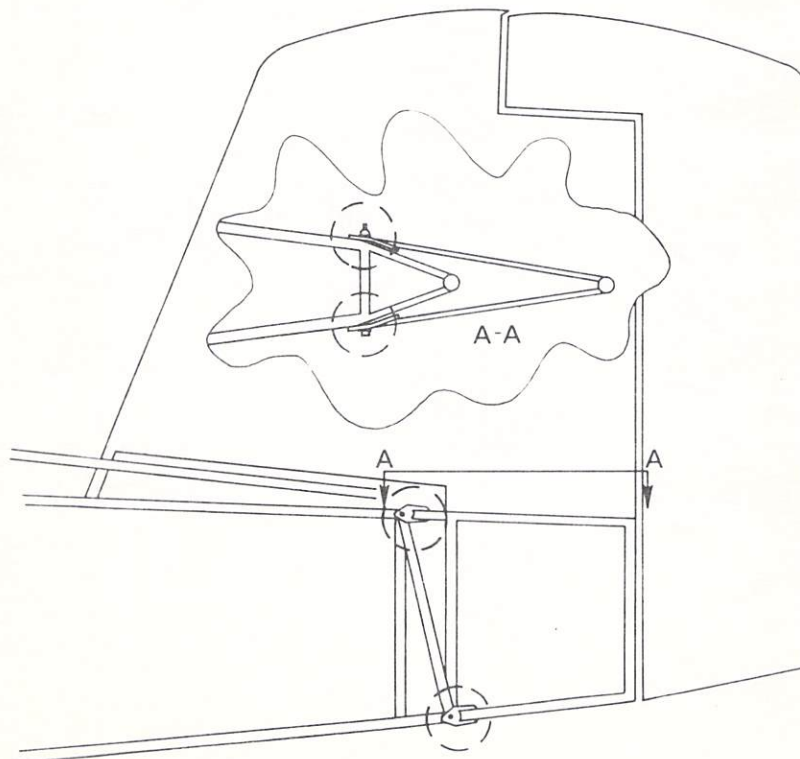
It has been reported that water may enter the forward tail post tube, due to inadequate sealing of the rear fuselage extension attach bolts.

Remove the lower attach bolt and determine if water is present. If water is present, allow to drain and dry. Then spray inside the tube through the bolt hole with Rust Ban or equivalent penetrating protection. Apply adequate portion of Permatex between the attach lugs and fuselage, and on the bolt head and nut. Reinstall and torque to 125 inch pounds. Repeat the sealing process for the upper attach bolt. Refer to Drawing below. NOTE: Circled areas to be sealed.

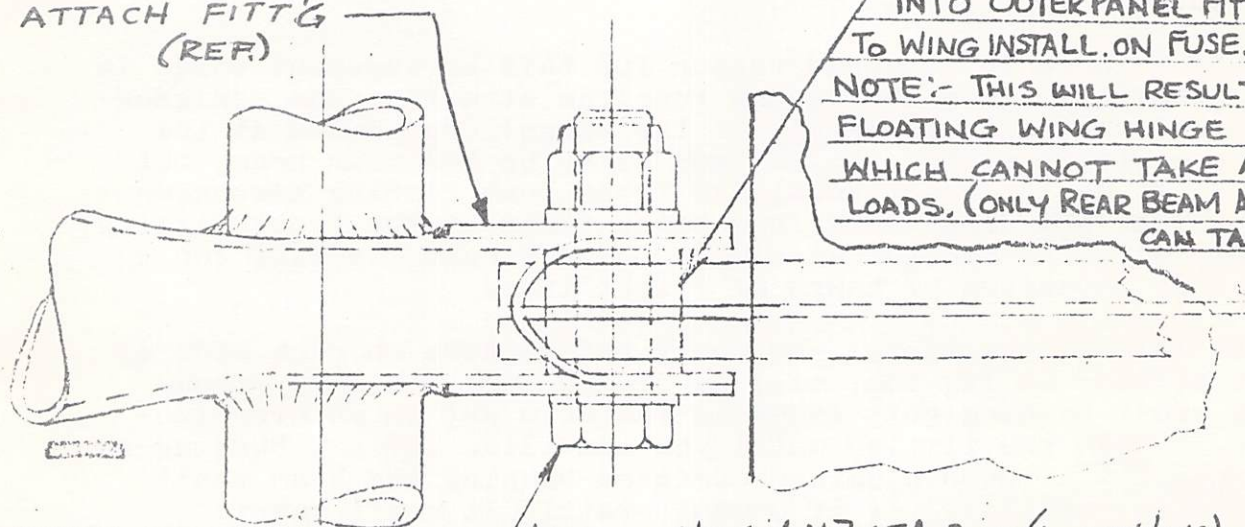
FUSE. OR C.S. FRONT BEAM  
ATTACH FITT'G  
(REF)

CHANGE FOR 1ST 100 A/C ONLY, THE FOLLOWING FRONT BEAM ATTACHMENT TO THE FUSELAGE OR C.S. SHALL BE ACCOMPLISHED AS SHOWN BELOW WHENEVER REPLACEMENT BUSHINGS AND BOLTS ARE INSTALLED AT THESE JOINTS. SINCE THE AN 7-20A (UPPER WING) & AN 7-15A (LOWER WING) BOLTS HAVE THE LEAST MARGIN OF SAFETY (COMPARED WITH THE BUSHING), IT IS VERY LIKELY THAT THE BOLT WILL SHOW THE FIRST SIGNS OF WEAR. IT IS THEREFORE CONSIDERED NECESSARY THAT BOTH THE BOLT & THE BUSHING BE REPLACED AS SHOWN BELOW WHENEVER NECESSARY.

INSTALL SINGLE NEW CLAMP-UP BUSHING (P/N 1002-151) INTO OUTER PANEL FITT'G PRIOR TO WING INSTALL. ON FUSE. OR C.S. NOTE:- THIS WILL RESULT IN A FLOATING WING HINGE FITTING WHICH CANNOT TAKE ANY DRAG LOADS. (ONLY REAR BEAM ATTACHMENT CAN TAKE DRAG LOADS!)

AN 8 (1/2 DIA. MAX.) BOLTS MAY BE INSTALLED HERE IN LIEU OF AN 7 BOLTS IF CUSTOMER DESIRES, BUT IT MUST BE A LIGHT DRIVE FIT!

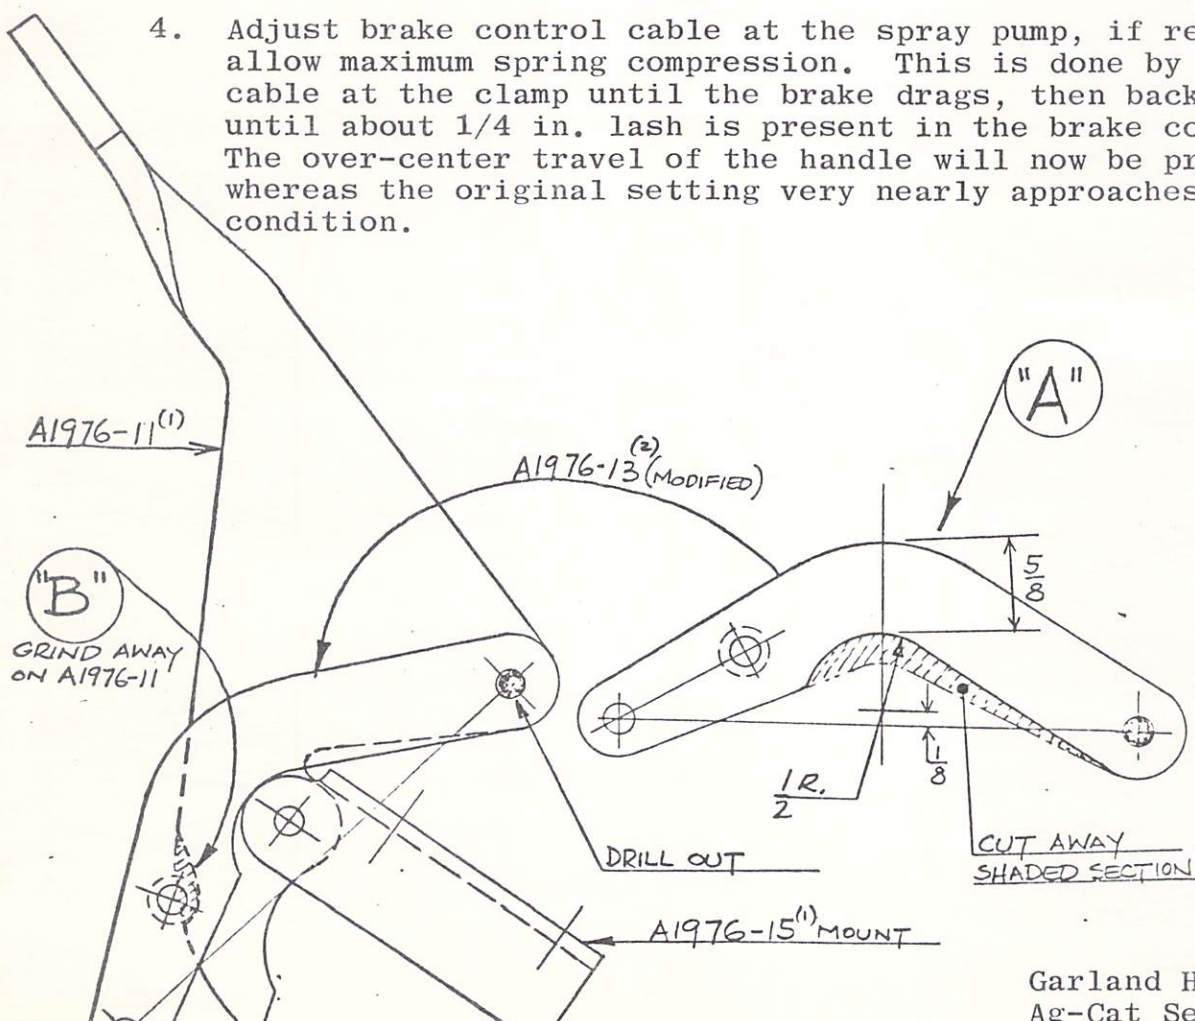
To reduce the possibility of inadvertently tripping the spray pump fan brake control the following rework should be accomplished, resulting in a greater amount of over-center travel of the control handle and a definite over-center lock.

1. Drill out the hinge rivet that attaches the dog-leg to the handle. Either grind or file the dog-leg (P/N A1976-13) to conform to the suggestions of the sketch shown below at "A".
2. Grind control handle as shown at "B" to allow greater travel of the stop spacer.
3. Assemble again, using a new rivet at the hinge or use a suitable AN-3 bolt and elastic stop nut.
4. Adjust brake control cable at the spray pump, if required, to allow maximum spring compression. This is done by tightening cable at the clamp until the brake drags, then backing off until about 1/4 in. lash is present in the brake control arm. The over-center travel of the handle will now be pronounced, whereas the original setting very nearly approaches an on-center condition.
