# AG-CAT SERVICE NOTES and BULLETINS

**GRUMMAN** AMERICAN AVIATION  
CORPORATION

AG-CAT SERVICE BULLETINS

## SERVICE BULLETIN INDEX

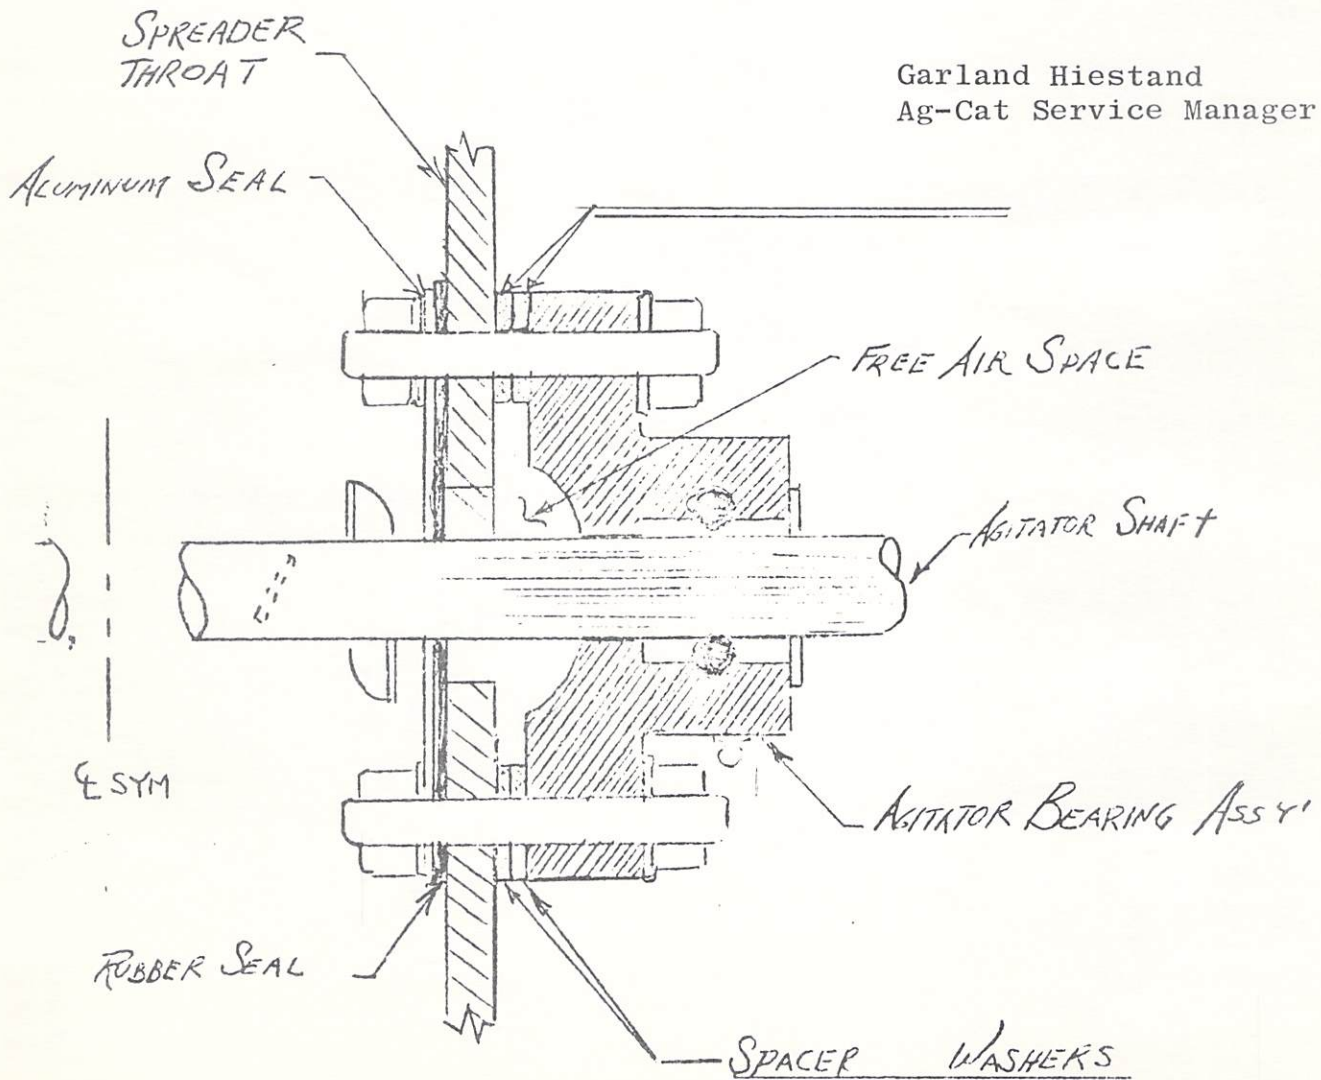
Greater service life and more satisfactory operation of the agitator bearings may be had by spacing them out from the spreader throat as shown in the attached sketch so that dust or other material that leaks by the inner rubber seal will fall or blow free.

Simply remove the two attachment bolts and insert a washer or spacer between the bearing and the aluminum throat. As a rule if the rubber seal is in good condition only dust will work past and into the bearing area, so a simple washer will be an adequate spacer. If more clearance is desired, then longer bolts must be used.

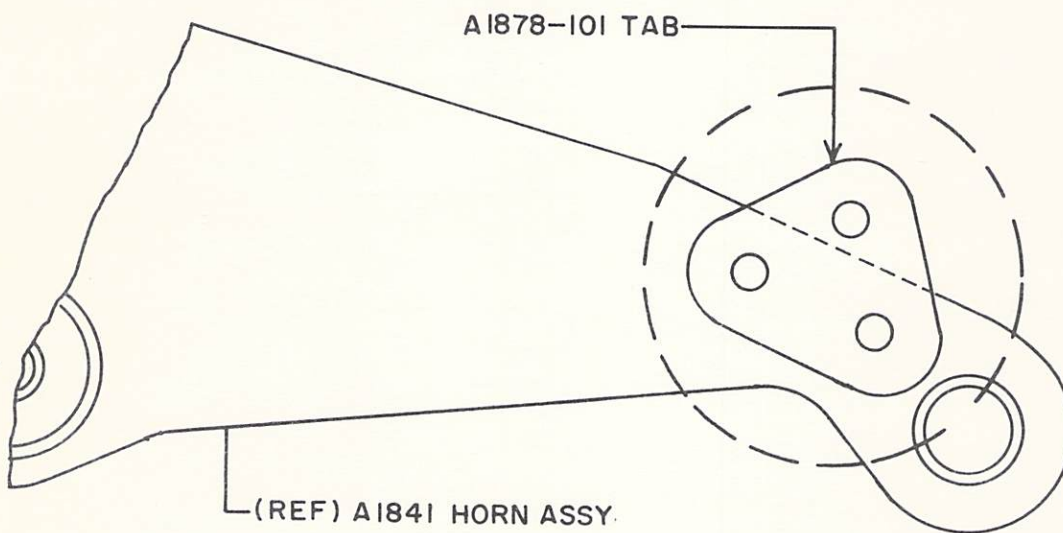
Field Reports indicate that the holes located on the A1878-101 tail wheel steering tabs have a tendency to elongate. (Ref. drawing below).

Effective on Grumman Ag-Cat S/N 1528 and up, these tabs will be heat treated to 160,000 p.s.i. All spare tabs ordered after July 1, 1975 will be heat treated accordingly.
